GLMRIS – Brandon Road

Appendix G - Phase I HTRW Site Assessments

**GREAT LAKES AND MISSISSIPPI RIVER INTERBASIN STUDY –
BRANDON ROAD**

APPENDIX G - PHASE I HTRW SITE ASSESSMENTS

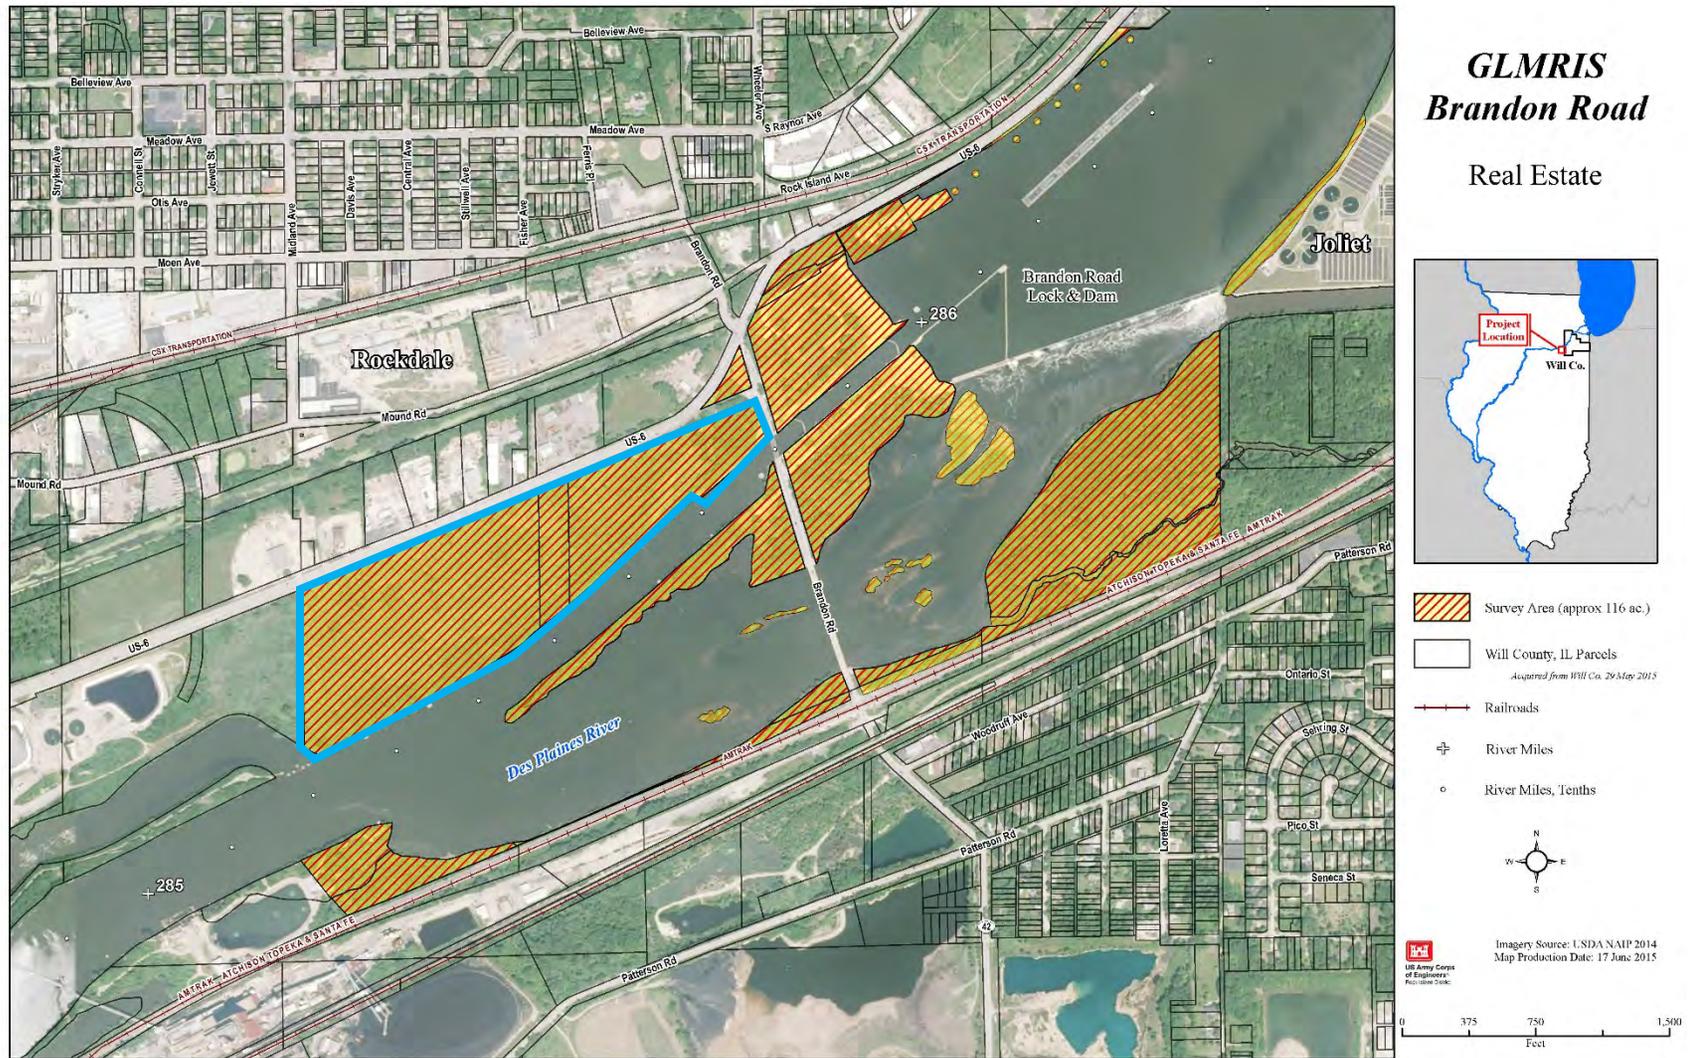
Figure 1: Parcels of Interest for Possible Future Use. Parcels of interest for this discussion are outlined in blue.

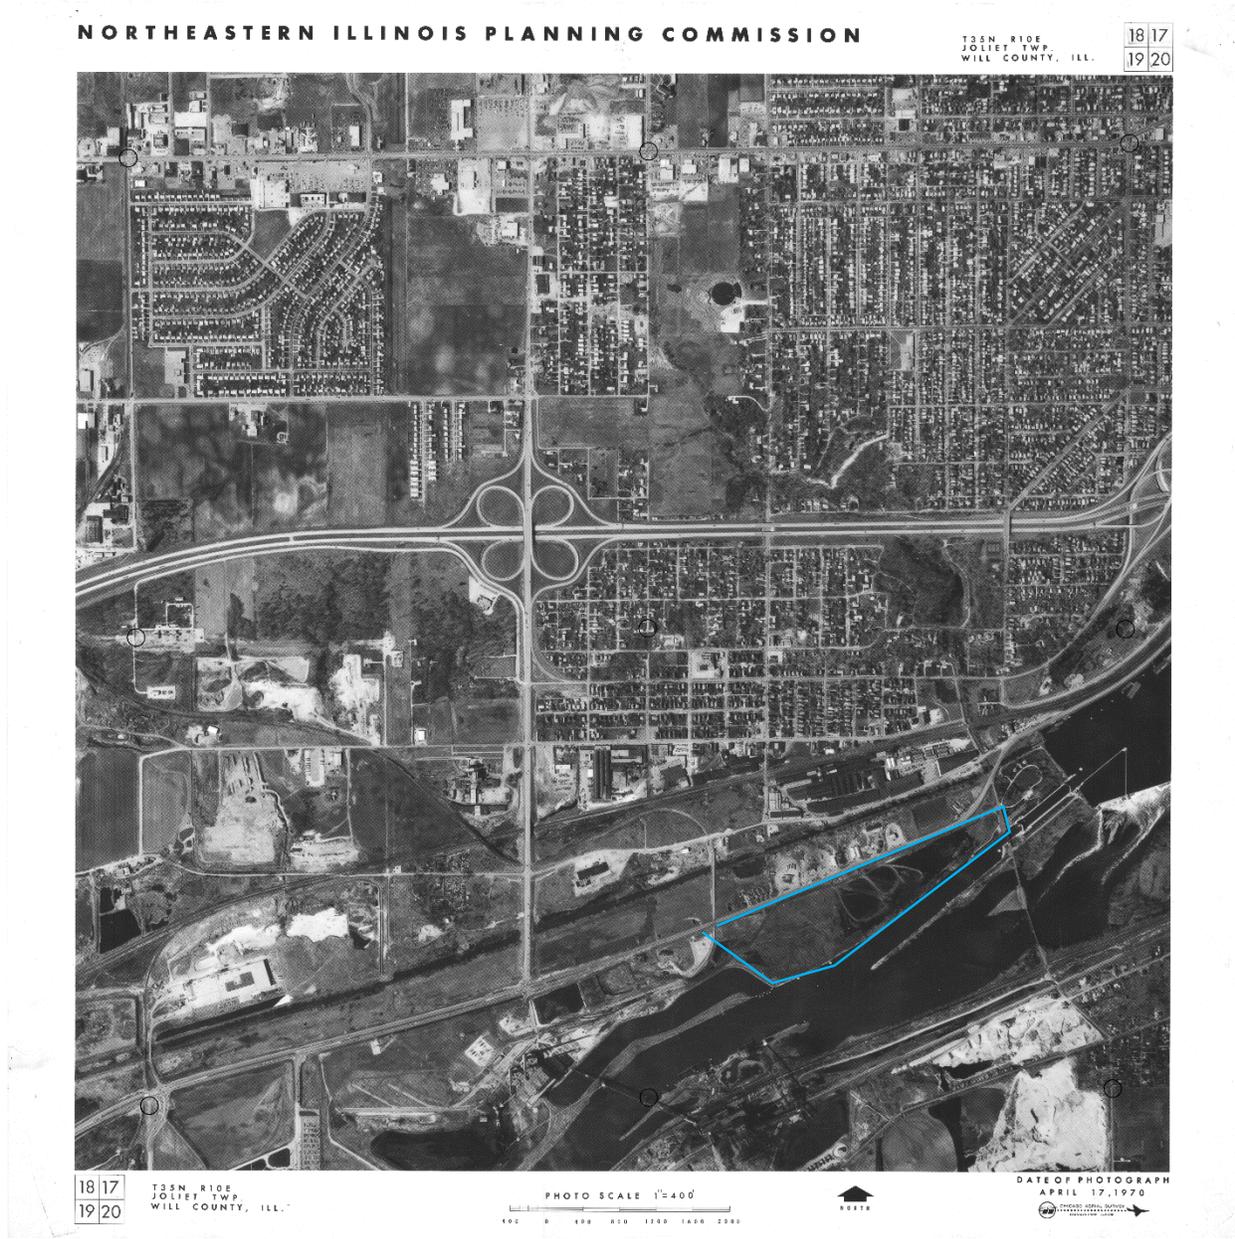
Figure 2: 1970 Aerial Photo, with parcels of interest outlined in blue. Note the haul roads on the property.

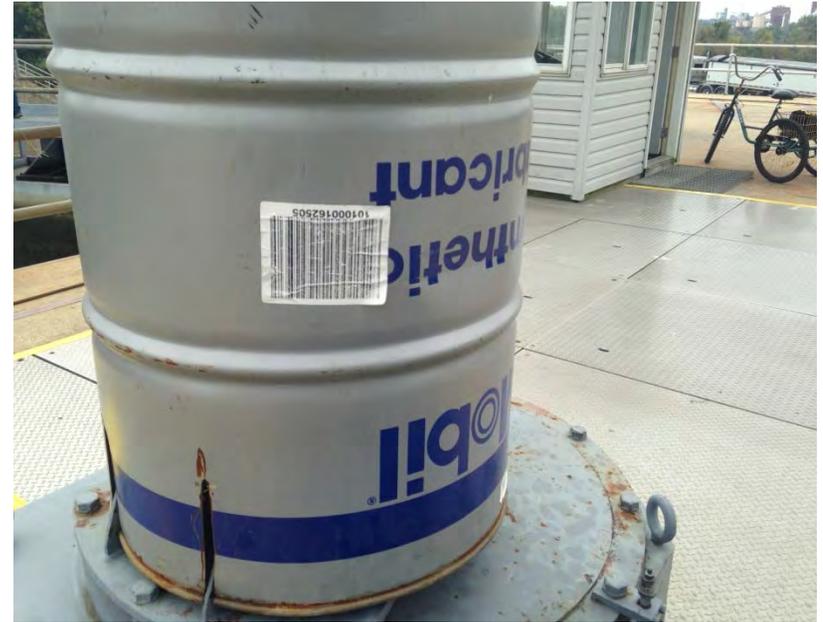
18. Hydraulic oil, southwest corner of lock chamber.

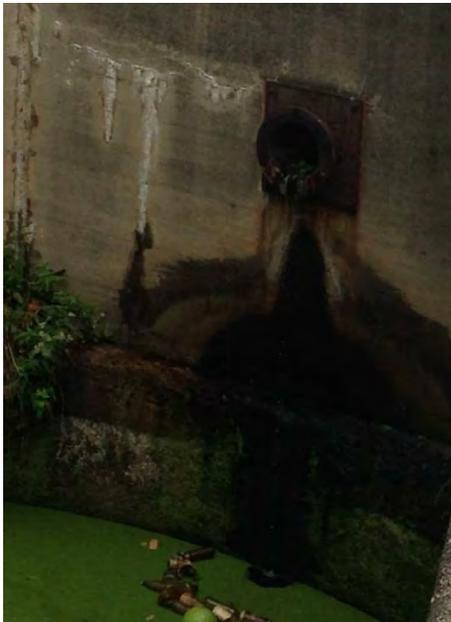
42. Leaking valve in bulkhead

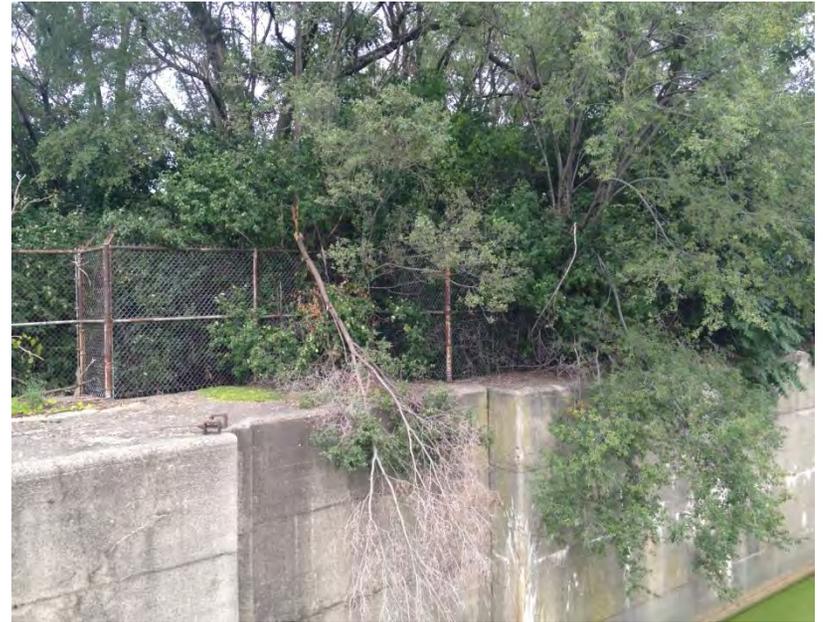
45. View west at abandoned lock chamber, overgrown fence.

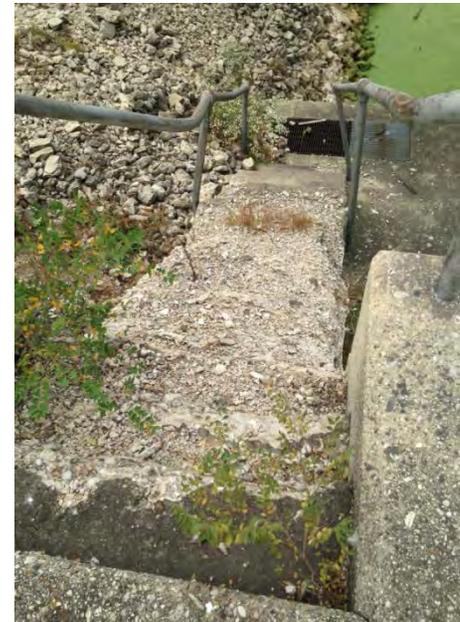
47. Deteriorated staircase, east side of abandoned lock chamber

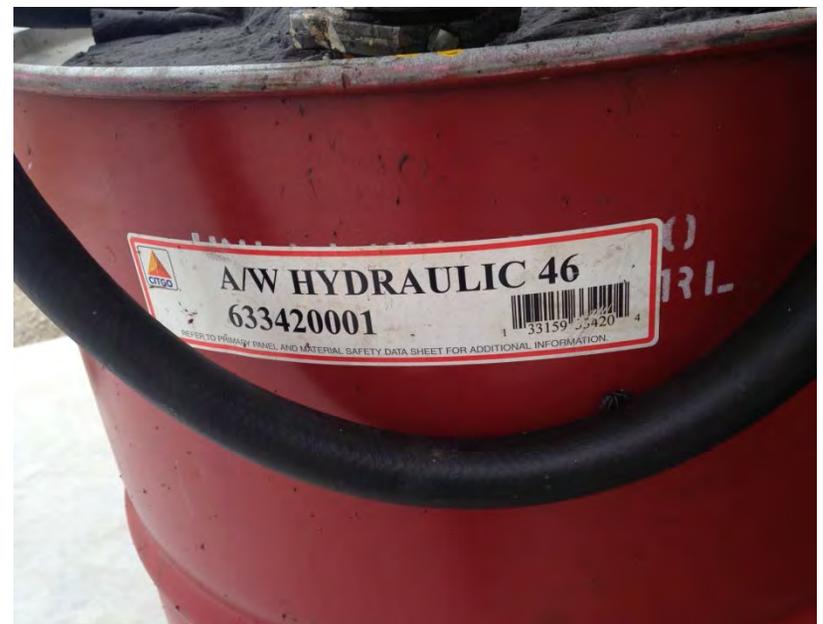
55. Hydraulic oil stored outside electrical shop

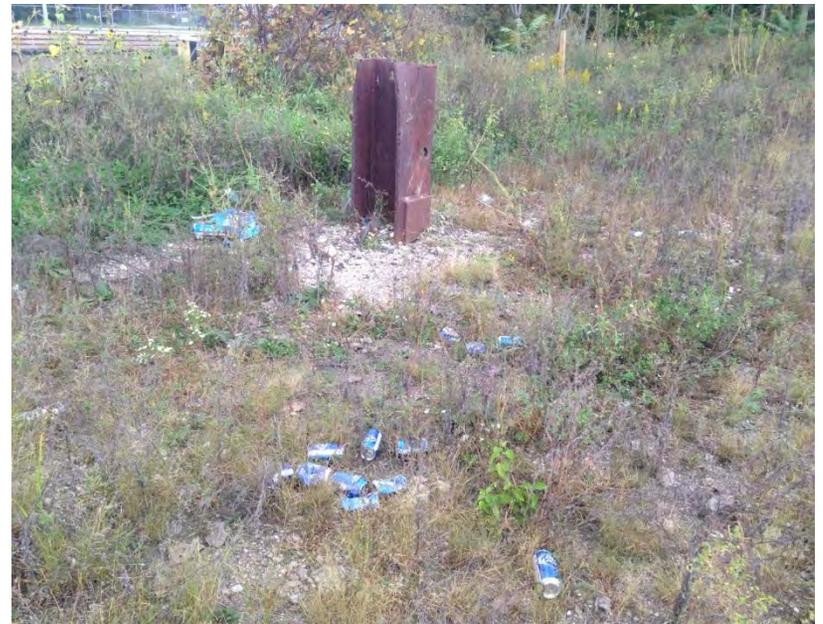
79. Garbage, steel member west of Brandon Road, south of river
