GLMRIS – Brandon Road

Appendix G - Phase I HTRW Site Assessments

**GREAT LAKES AND MISSISSIPPI RIVER INTERBASIN STUDY –
BRANDON ROAD**

APPENDIX G - PHASE I HTRW SITE ASSESSMENTS

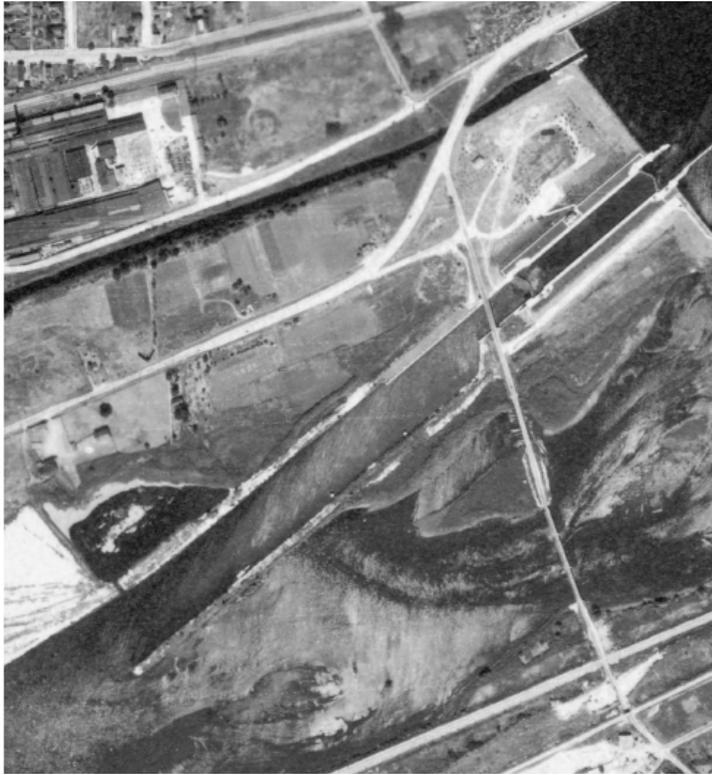
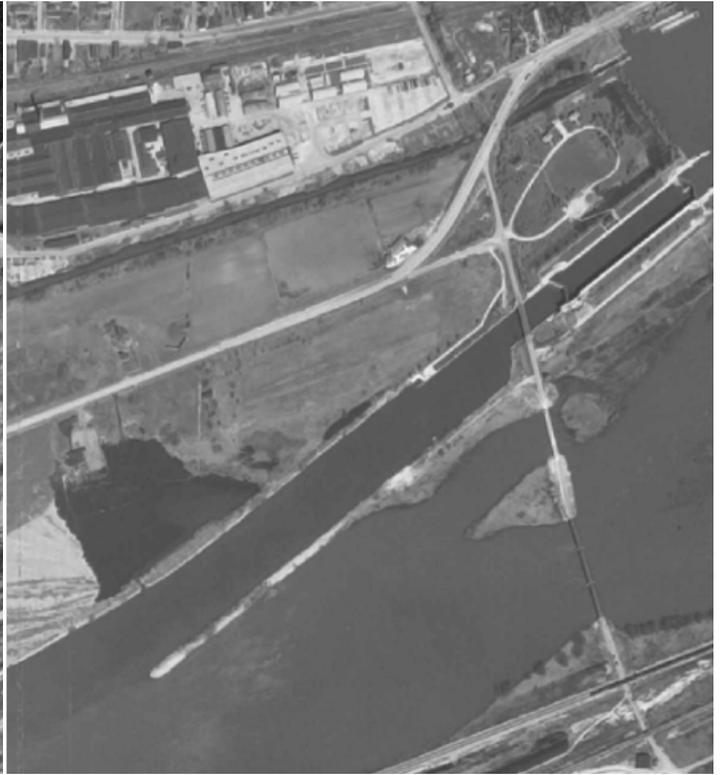
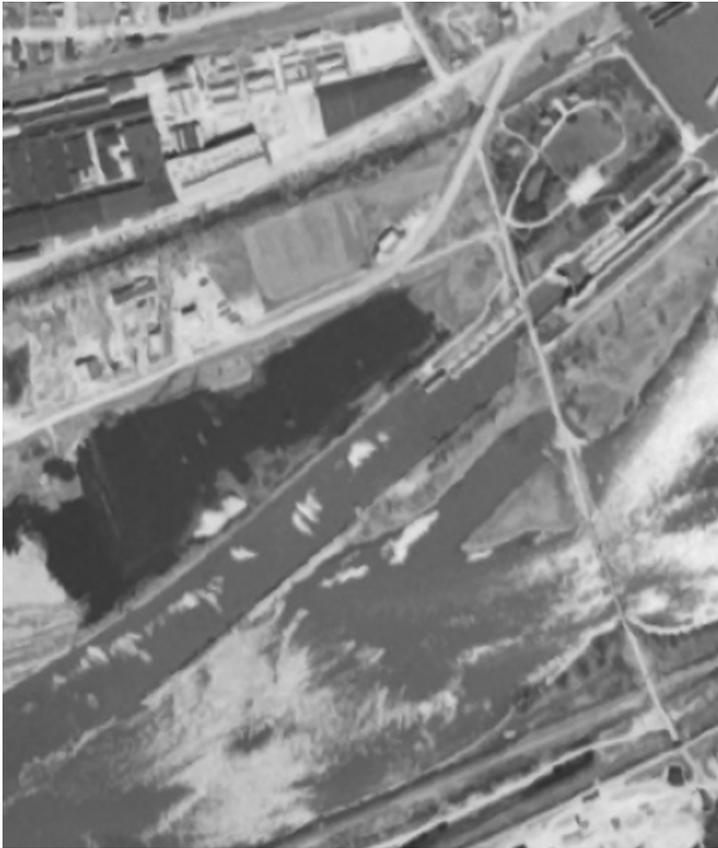
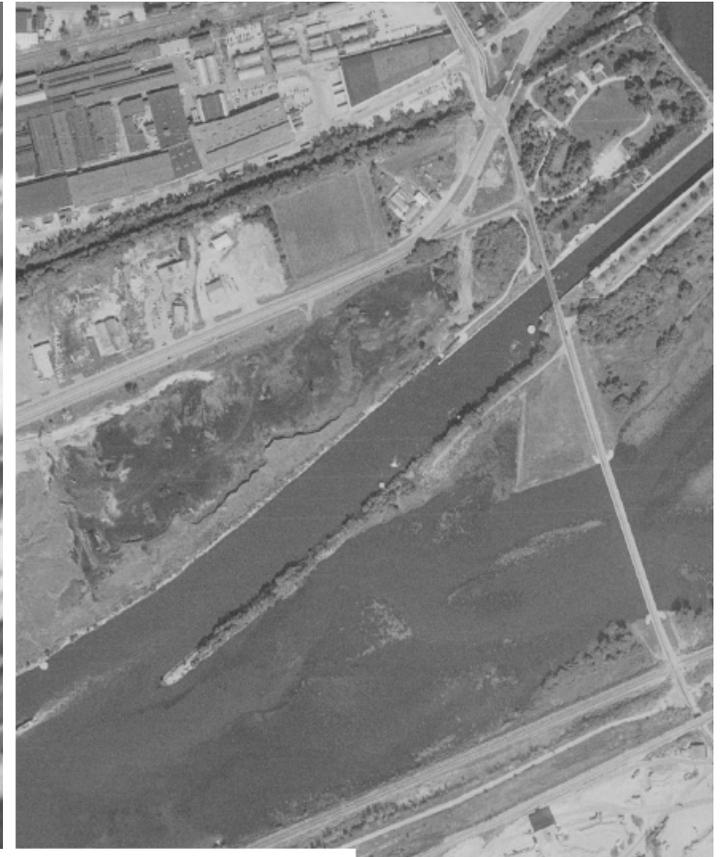
4. For the area of interest defined above, the most conclusive information on past usage comes from the historical aerial photos. These photos begin in 1939, after the Brandon Road lock and dam have been constructed. One new historical aerial was found, for 1970, to add to the progression.

- area.
- b. From 1939 through 1962 the dark area appears to be filled with water and getting larger over time.
 - c. In 1970 (Figure 2), the area in question is still dark, but the southern end appears to have haul roads and is being filled in. The northern end of the area appears to be water still, but possibly with vegetation growing in an island. The area being filled is dark, which could indicate water, topsoil, or other materials such as fly ash. From the aerial photo, it is not possible to tell what the fill material is.

9. It is recommended that a phase II investigation be conducted on this property prior to planning any development. The investigation should identify the nature and extent of materials within the footprint of the land that USACE would use, including the horizontal and vertical extent. Assuming that the land was filled with anthropogenic materials, samples should be taken for chemical analysis, to determine whether the material is characteristically hazardous and to determine the appropriate disposition of any excavated materials. It is recommended that a geotechnical investigation be conducted in conjunction with the environmental investigation, so that a complete set of conditions is available for future planning.

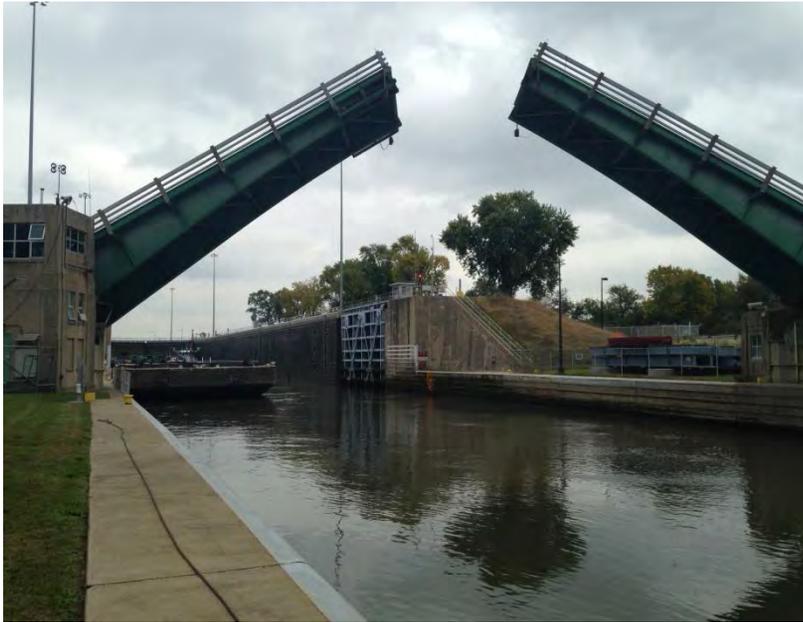
1. Looking north into lock chamber, lower gates open

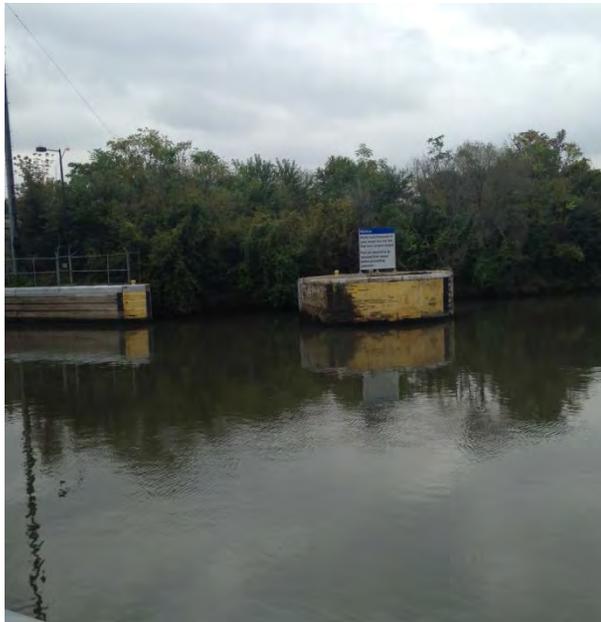
3. Facing east, west of Brandon Road bridge

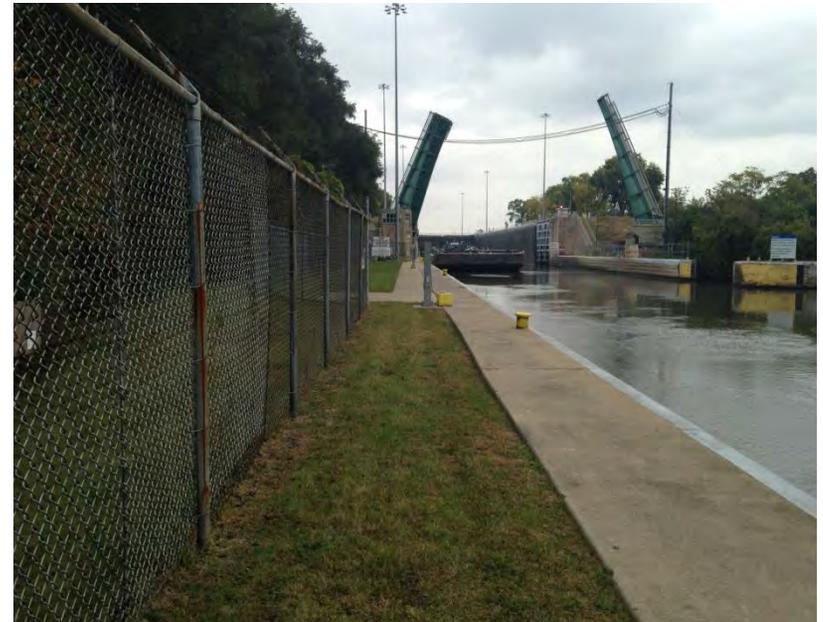
4. West of lock chamber, facing east along fence line.

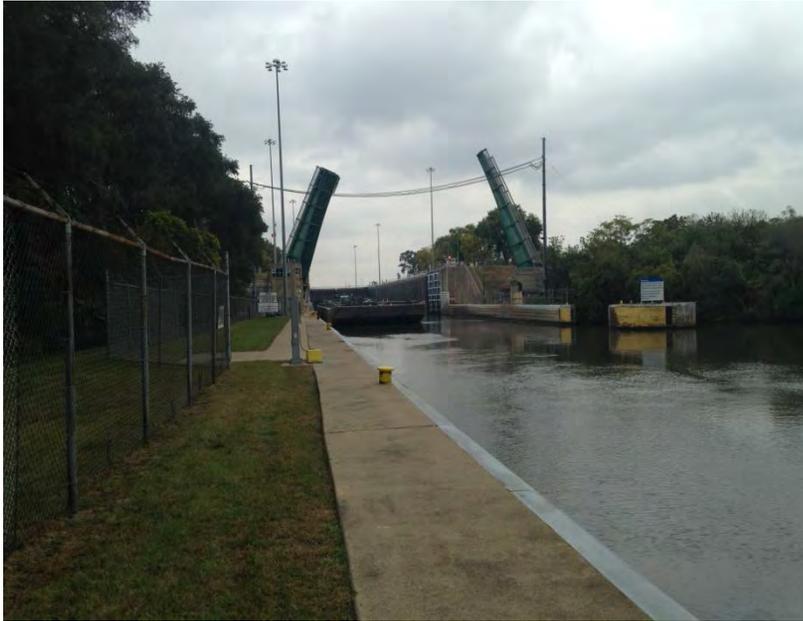
5. West of lock chamber, facing east along fence line

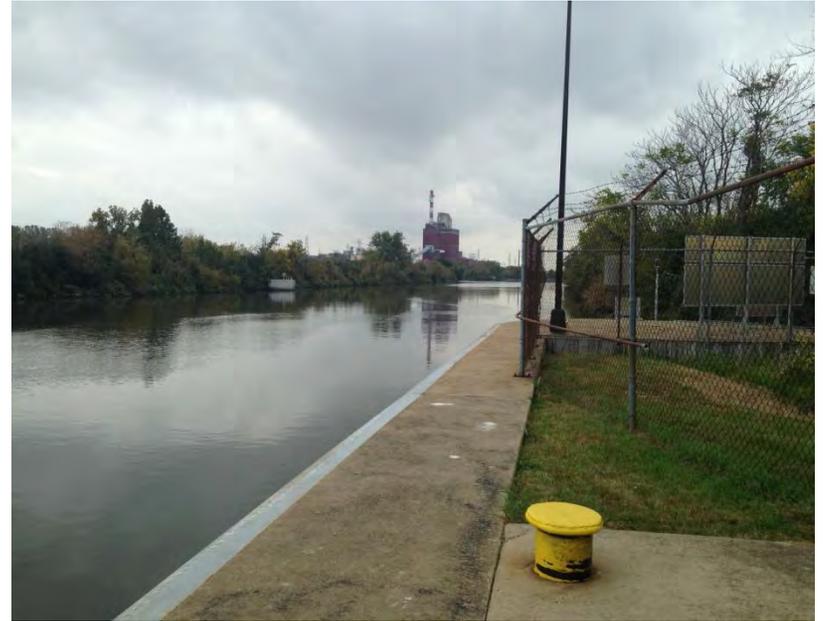
6. West of dam, facing west toward Joliet Generating Station

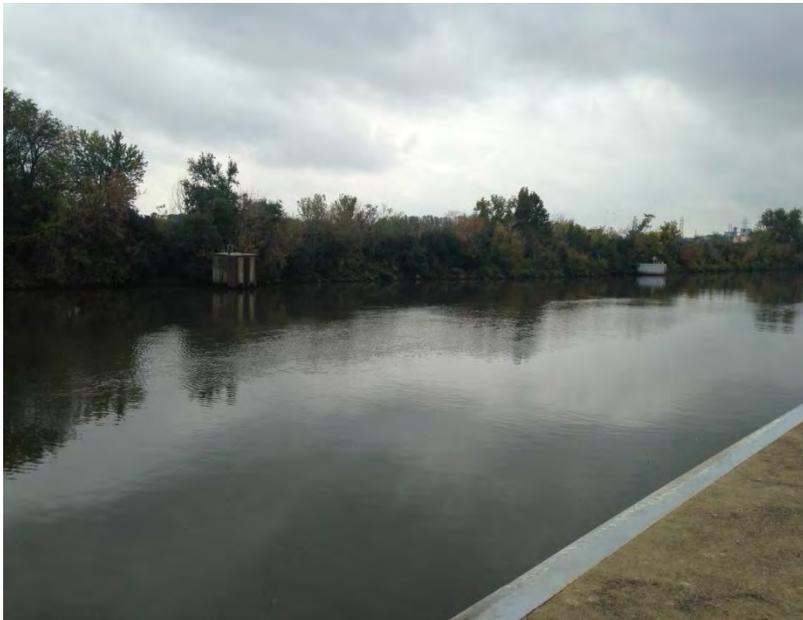
7. West of dam, facing south across approach channel

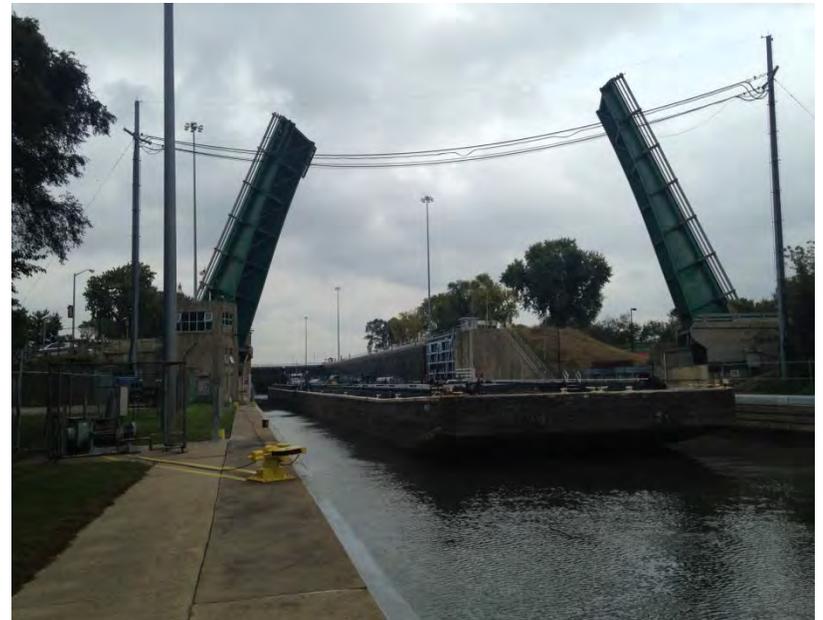
8. West of dam, facing east during barge passage

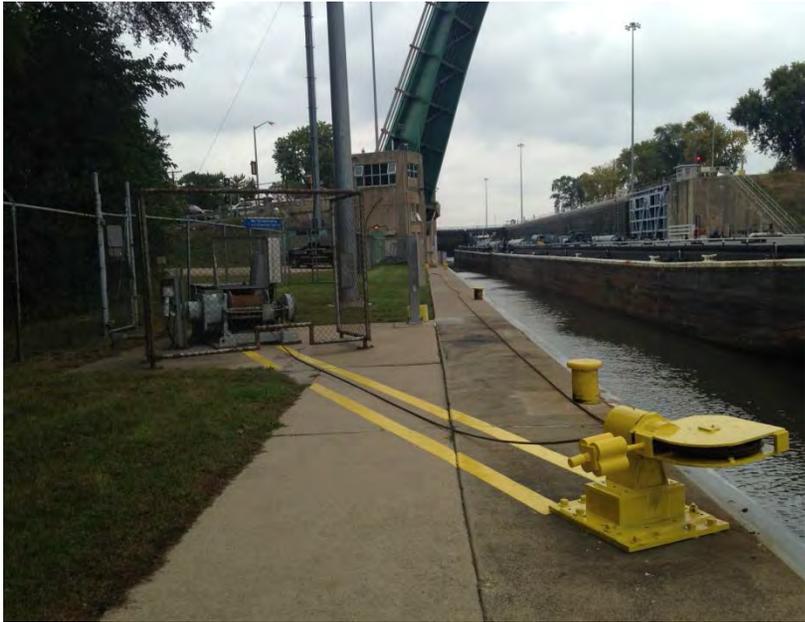
9. Lower tow haulage.

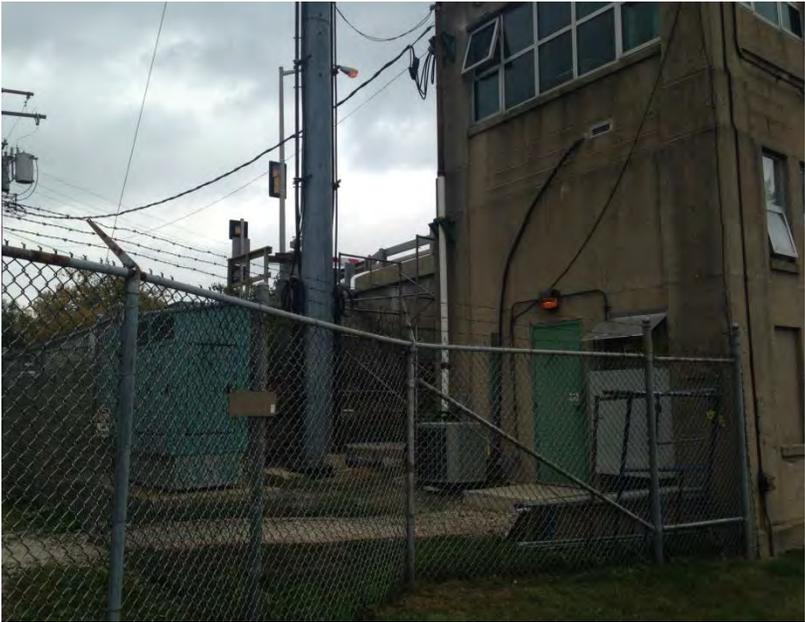
10. Brandon Road draw bridge control house

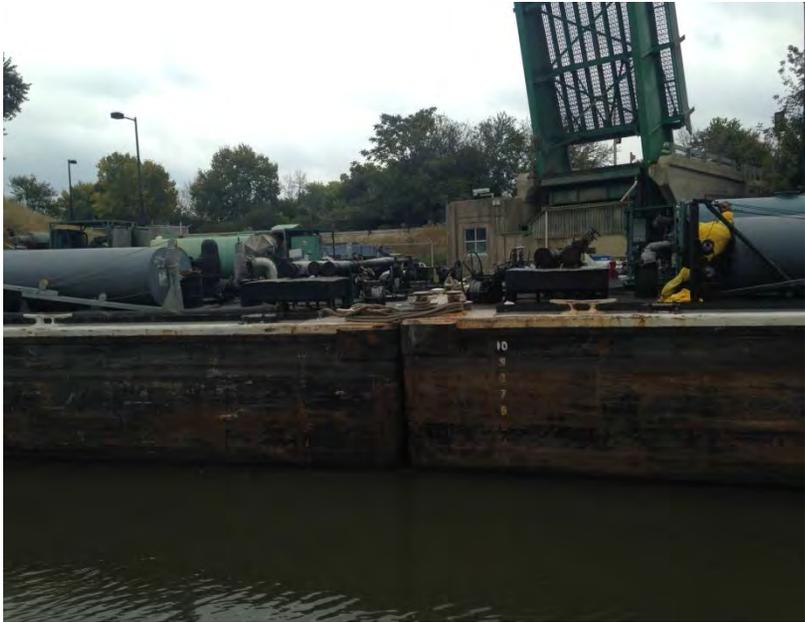
11. Chemical barge exiting lock chamber.

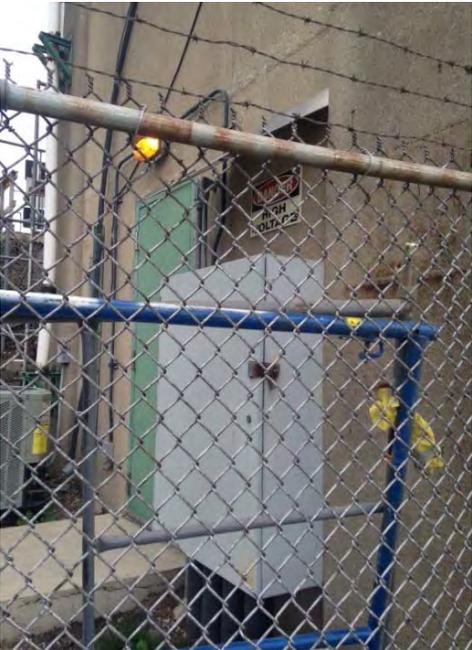
12. Breaker panel outside bridge control house.

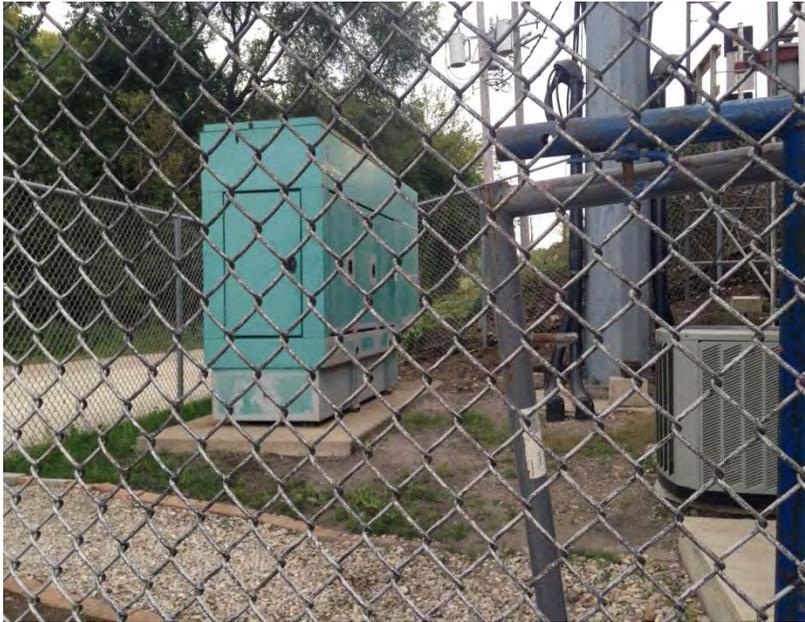
13. Electrical equipment outside Brandon Road Bridge control house.

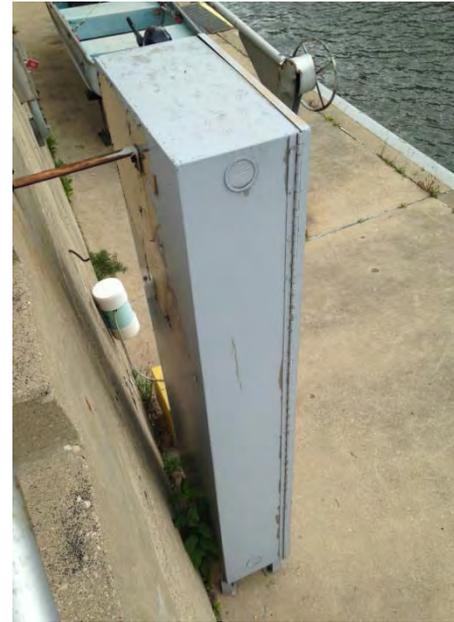
14. Electrical panel on southwest corner of lock chamber.

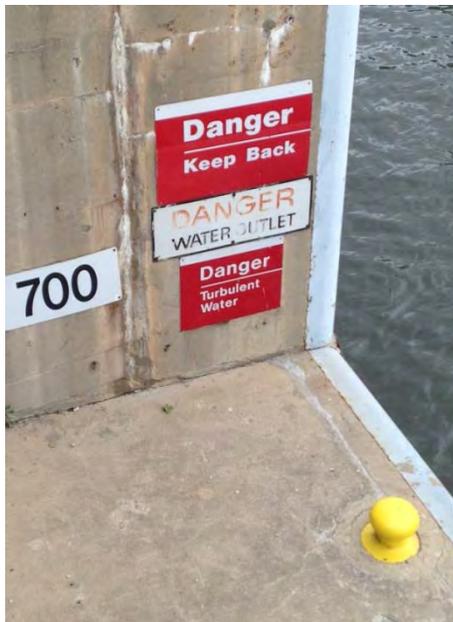
15. Southwest corner of lock chamber, safety signage for emptying valve.

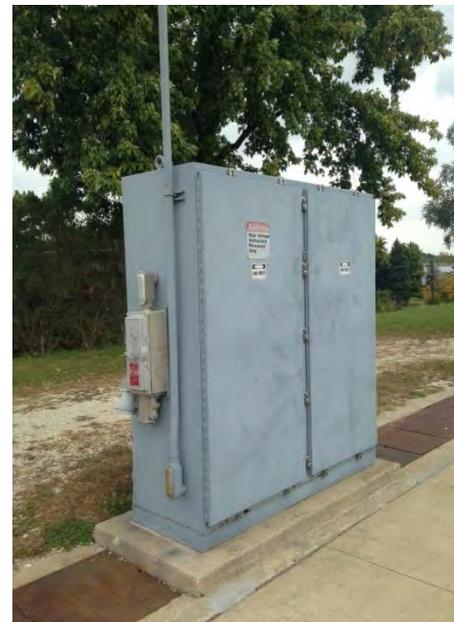
16. Electrical panel west of lock chamber.

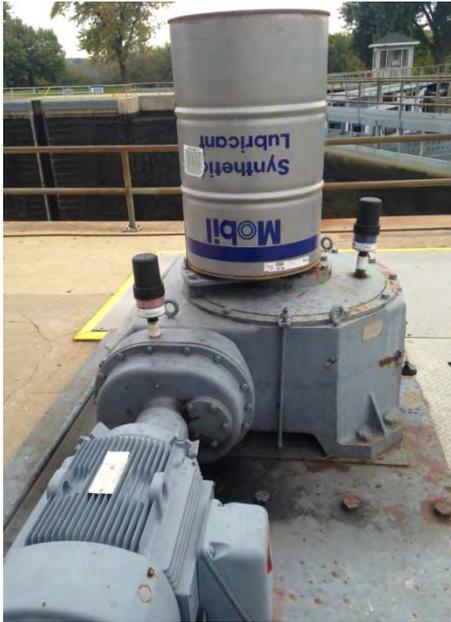
17. Mechanical equipment, southwest corner of lock chamber.

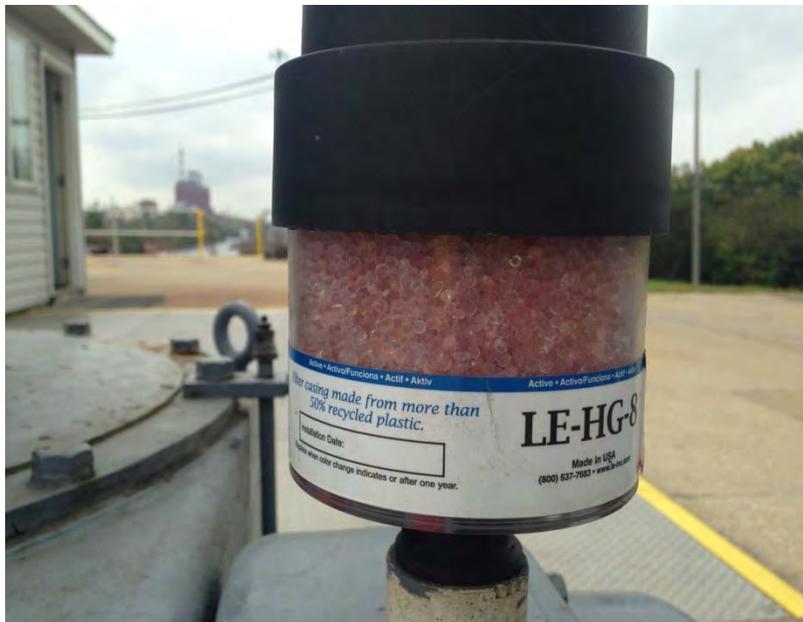
19. Desiccant breather to isolate lubricants from humidity. Polyester, silica gel filter media.

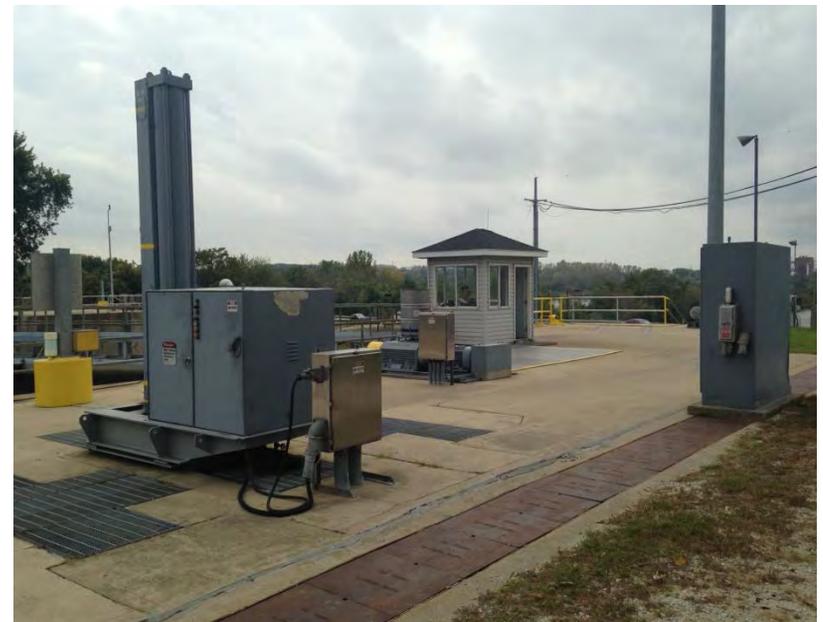
20. Mechanical equipment, southwest corner of lock chamber.

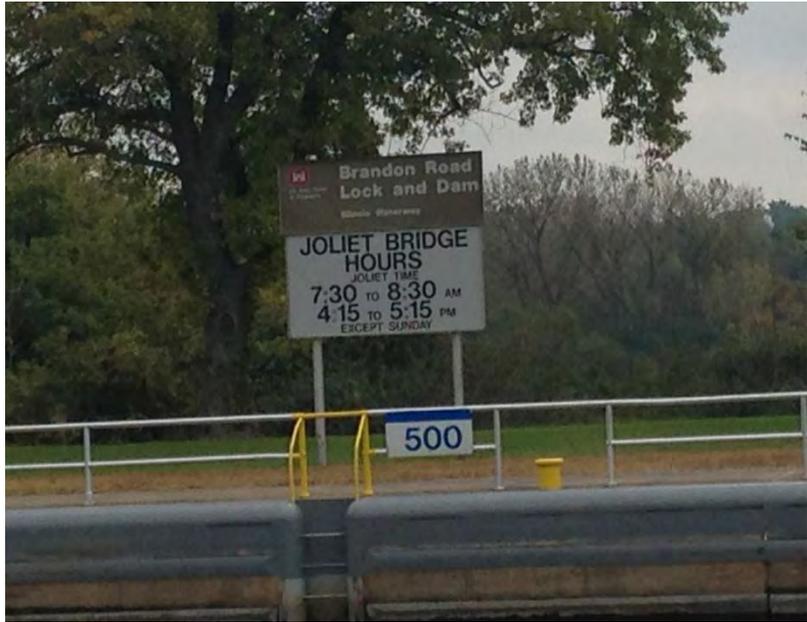
21. Signage showing drawbridge hours.

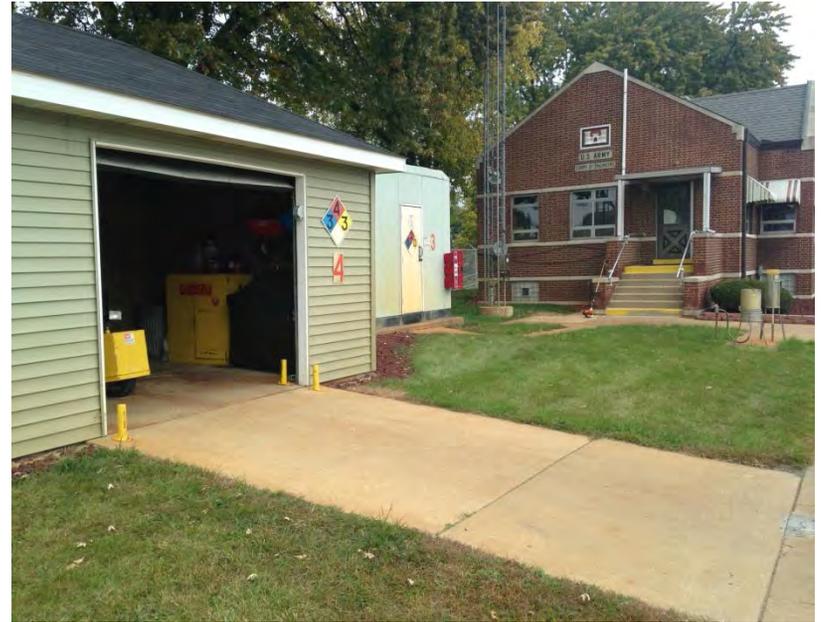
22. Garage south of lock house.

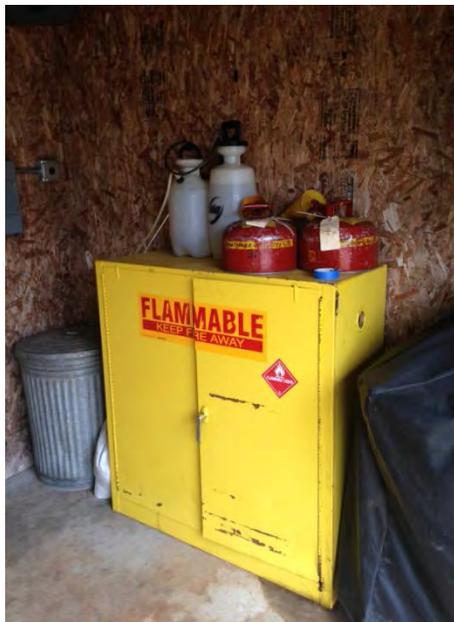
23. Fire cabinet, garage south of lock house.

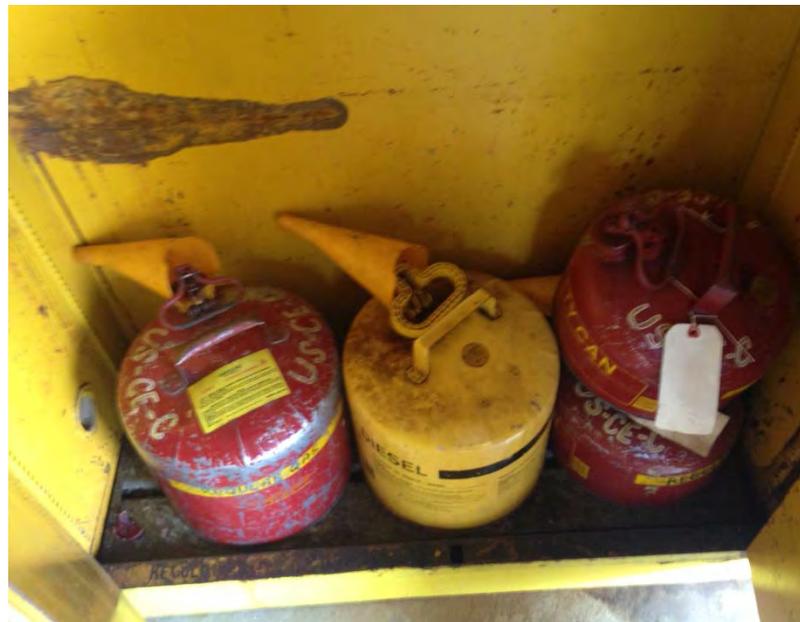
- a. Industrial drums – 55 gallon drums of hydraulic oil are stored near the electrical shop and are in use at each of the four corners of the lock chamber.
- b. Sacks of chemicals – No.
- c. Damaged or discarded automotive or industrial batteries – No.
- d. Pesticides, Herbicides, Paints or Other Chemical in Individual Containers greater than five (5) gallons in volume or fifty (50) gallons in the aggregate? Paints and herbicides are stored in lockers by the electrical house. Small containers of gasoline are stored in a fire cabinet in a garage near the lock house.

24. Gasoline storage, garage south of lock house

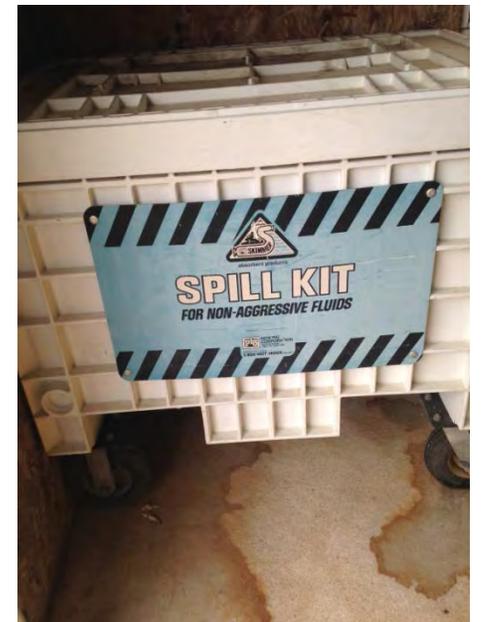
25. Spill kit, garage south of lock house.

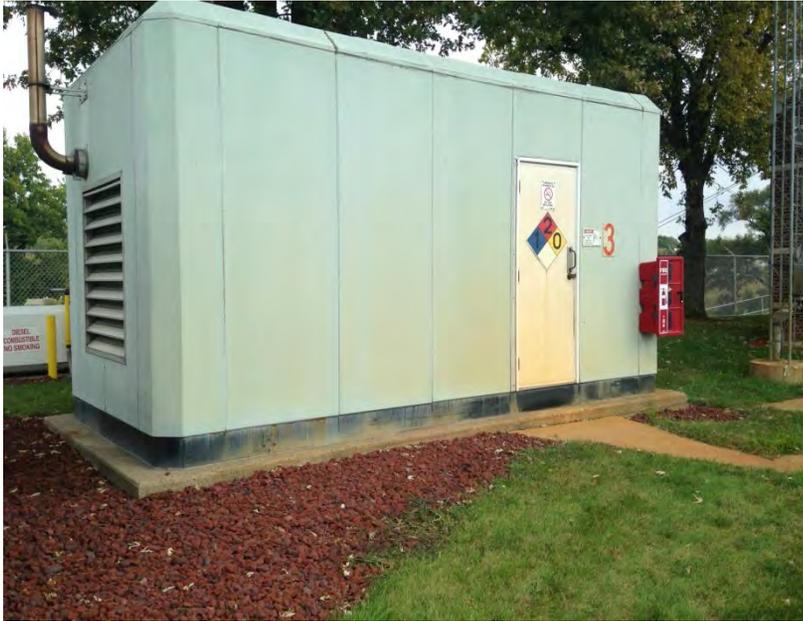
26. Transformer south of lock house

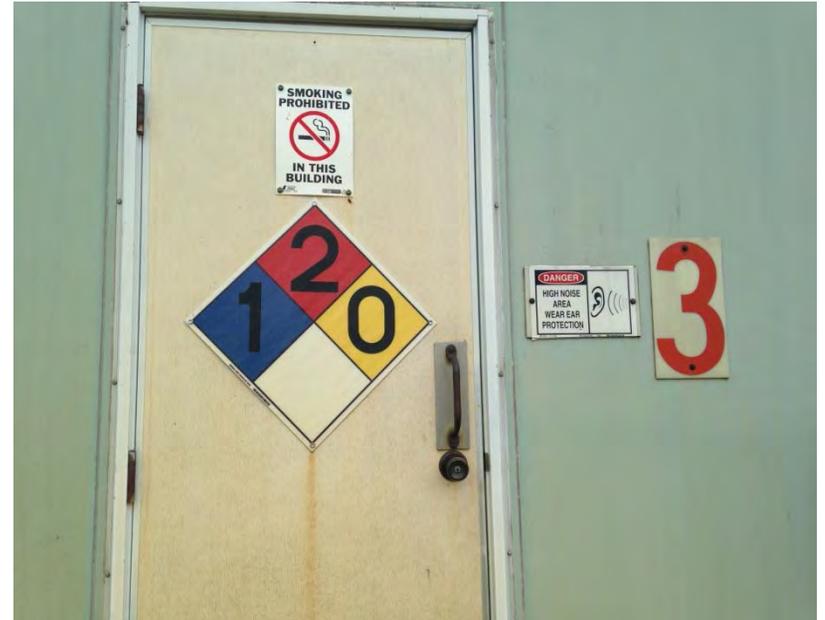
27. Transformer south of lock house

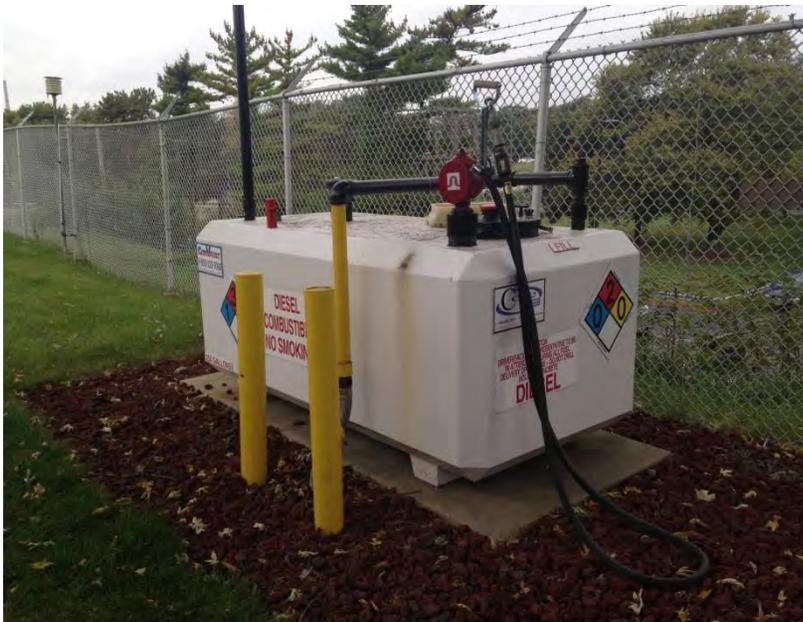
28. Diesel storage tank south of lock house, 250 gal.

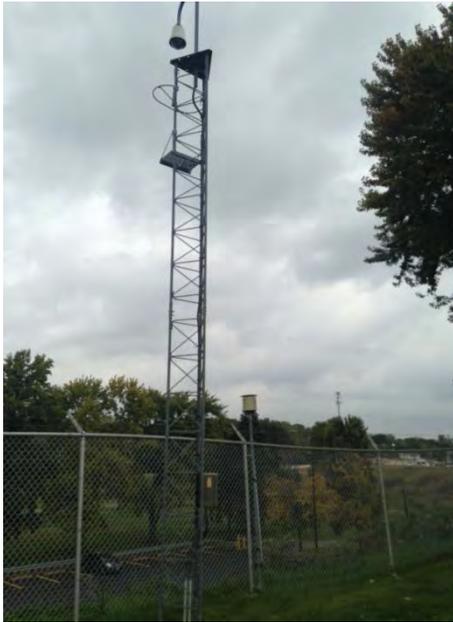
29. South of lock house

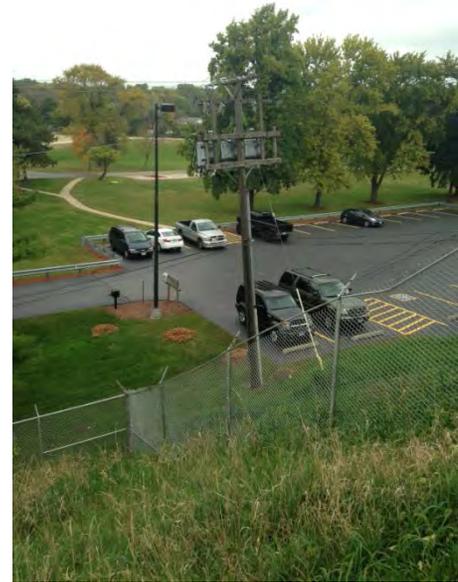
30. South of lock house, facing power pole, parking lot

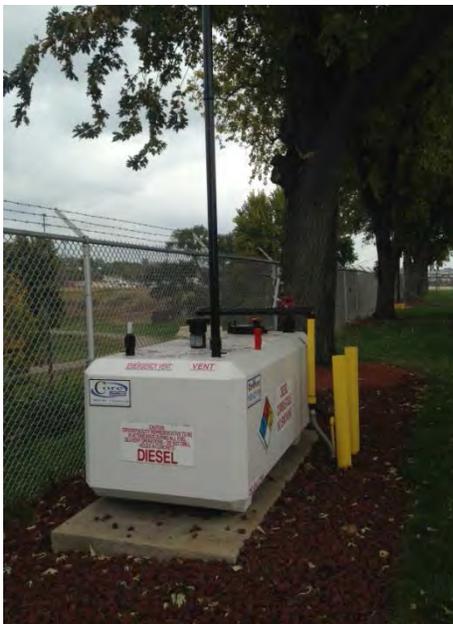
31. Diesel storage south of lock house

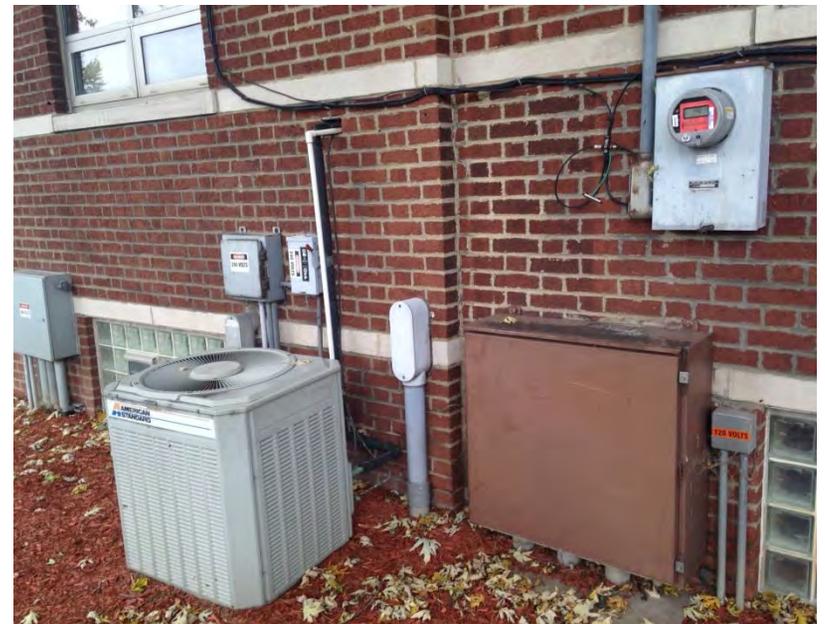
32. Rear of lock house

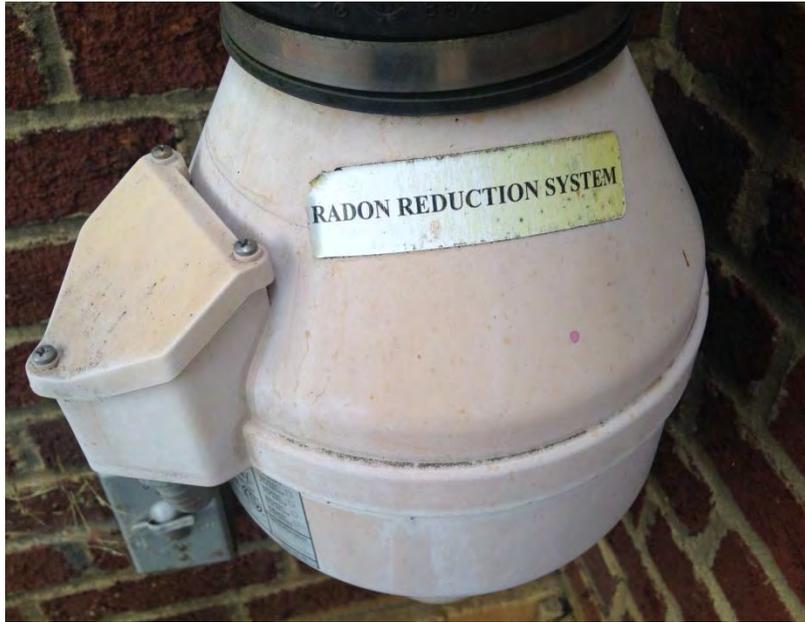
33. Radon reduction system, south of lock house

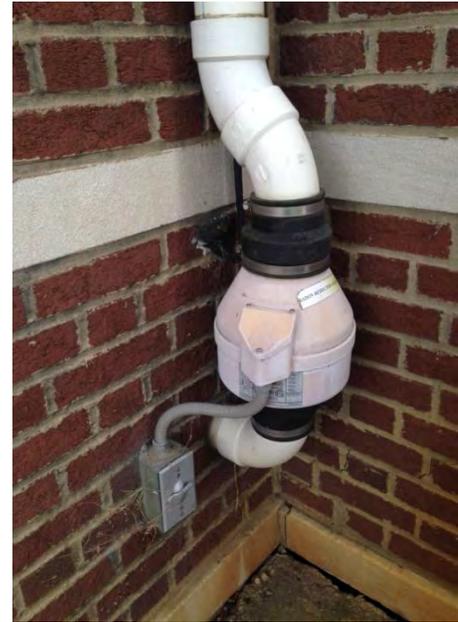
34. Radon vent, south of lock house

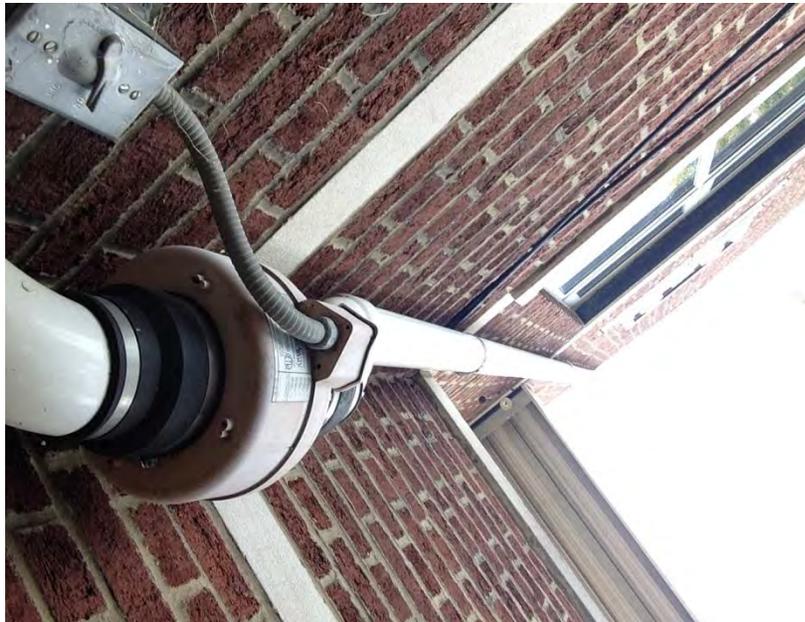
34. Radon reduction system, south of lock house

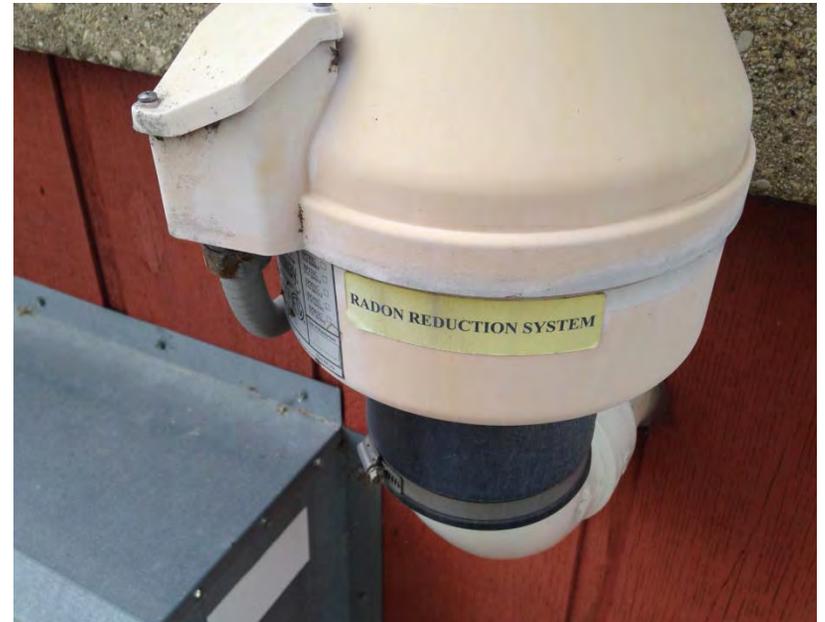
35. Radon reduction system, north side of lock house

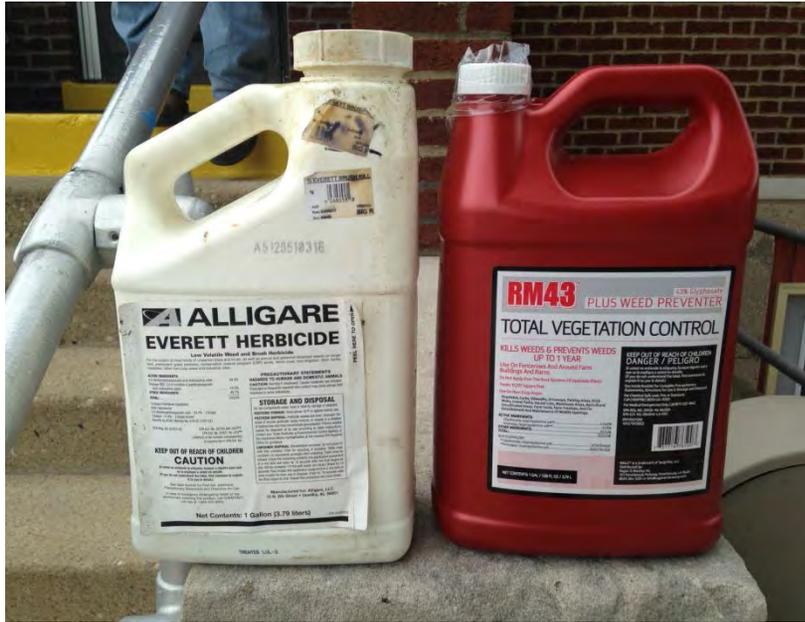
36. Herbicides in use the day of site visit.

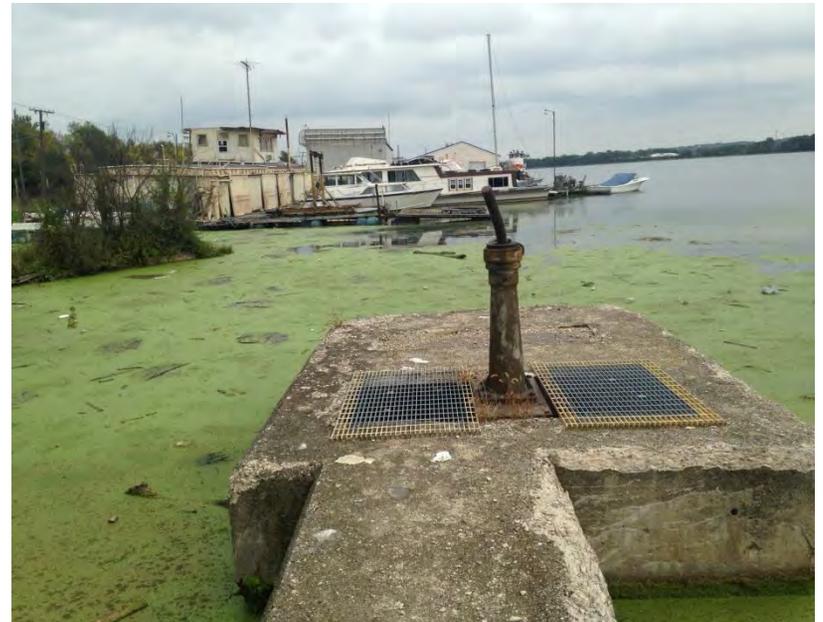
39. View northeast from abandoned I&M canal lock chamber

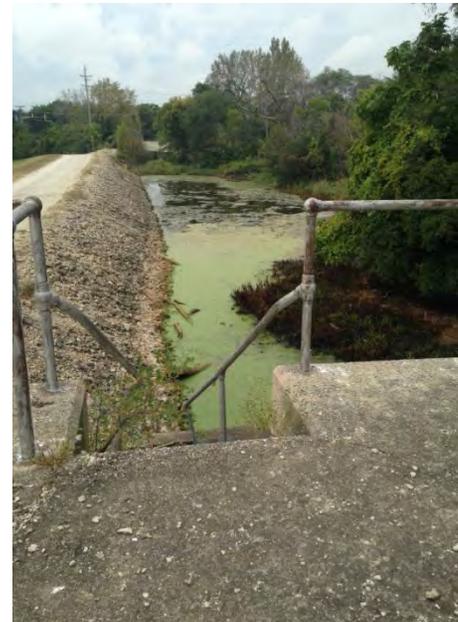
43. View south on I&M canal

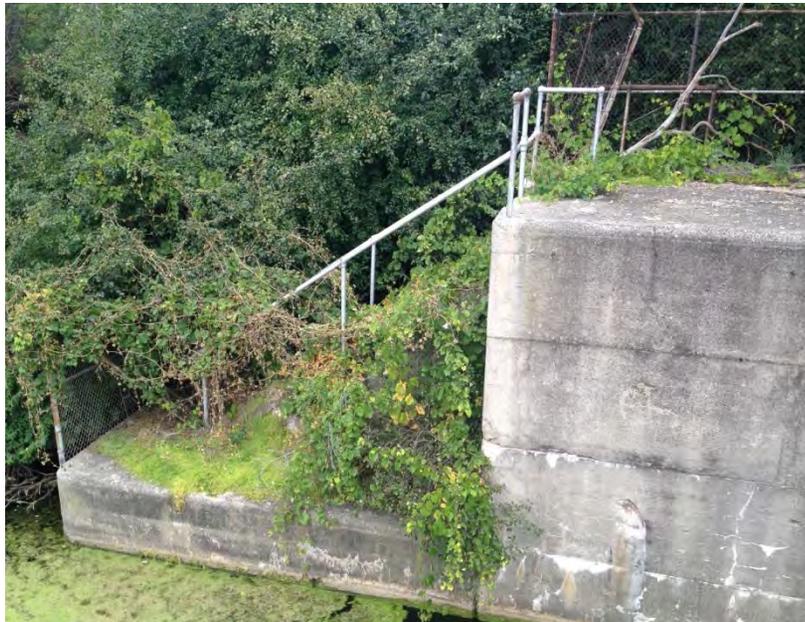
46. View facing west at abandoned lock chamber, overgrown staircase

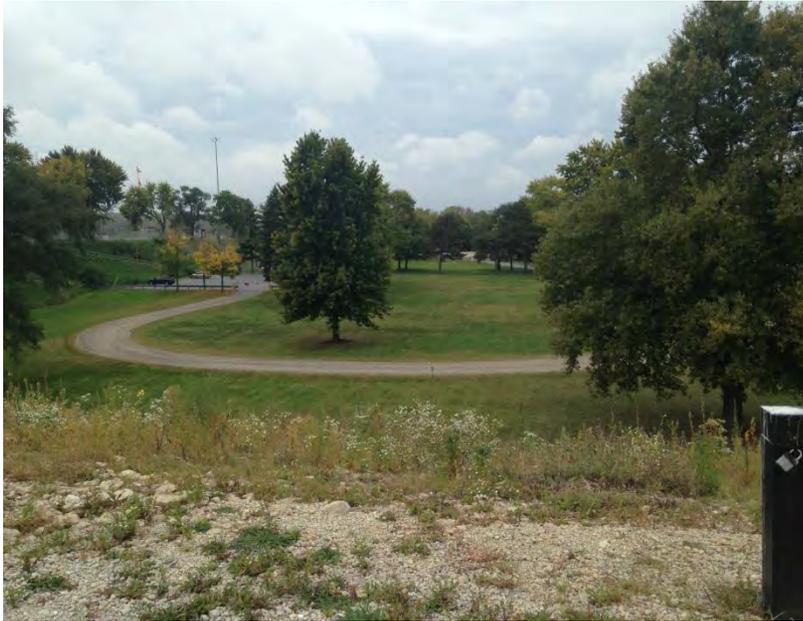
48. View south to lower lock site

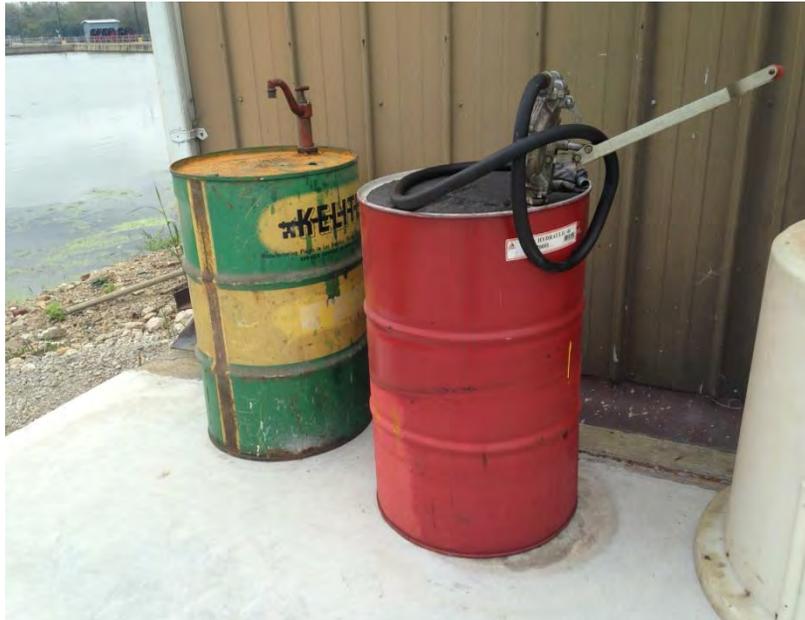
52. Drums stored on concrete pad outside electrical shop.

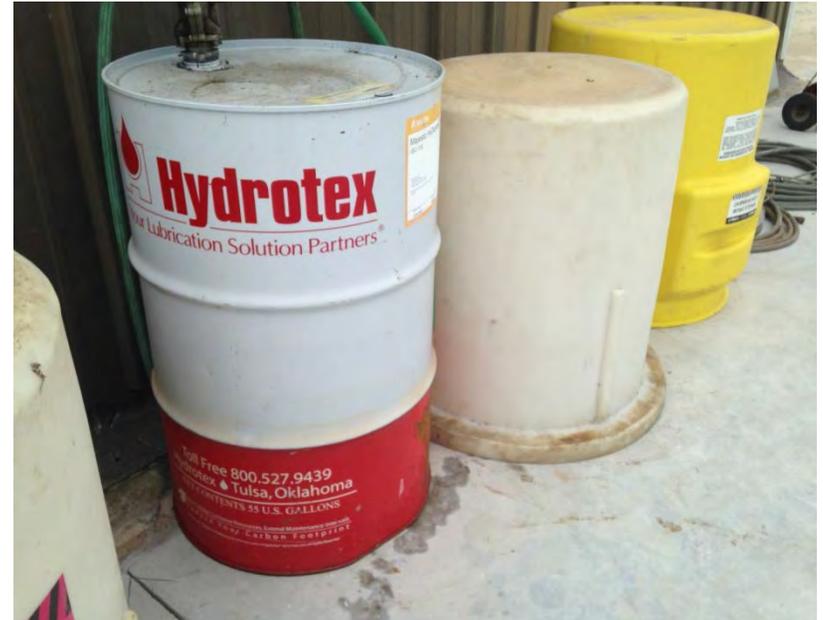
53. Drums stored on concrete pad outside electrical ship.

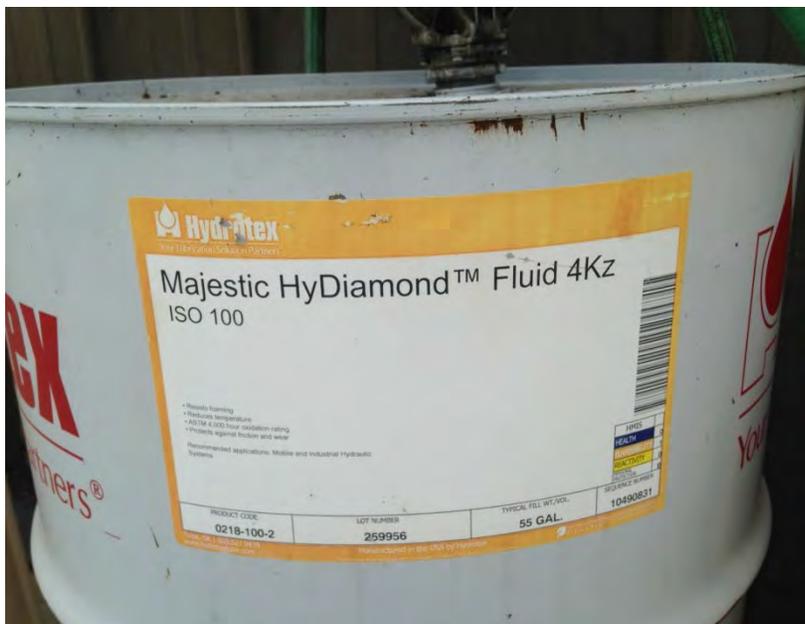
54. Hydraulic oil stored outside electrical shop

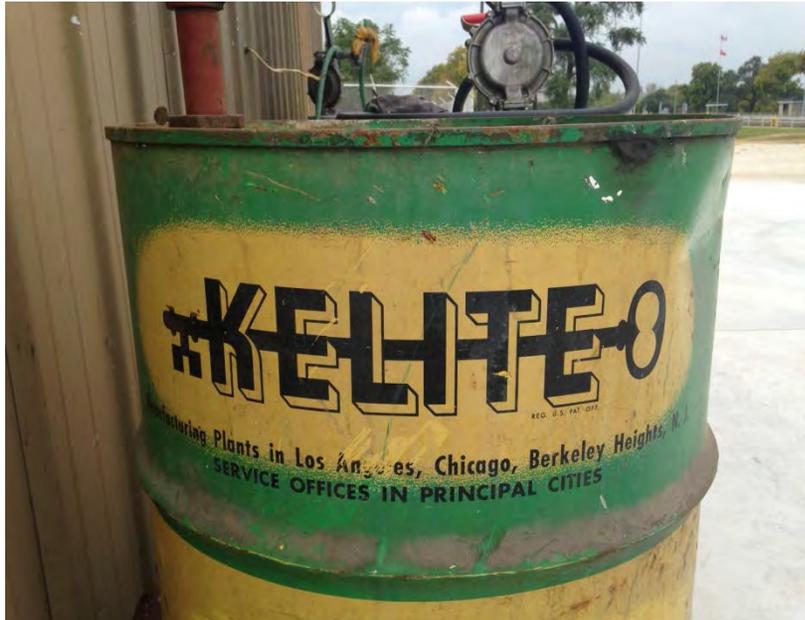
56. Vintage drum containing ?

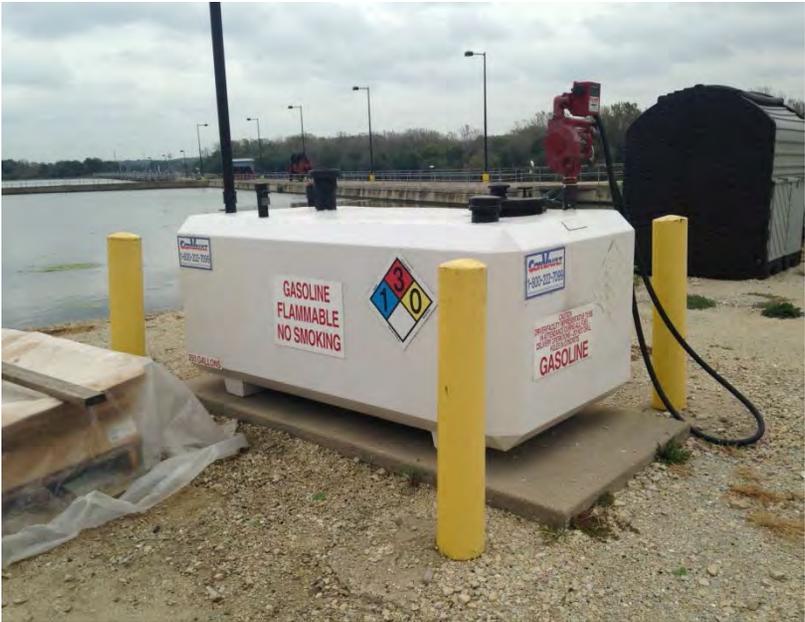
63. 250 gallon tank of gasoline
