GLMRIS – Brandon Road

Appendix G - Phase I HTRW Site Assessments

**GREAT LAKES AND MISSISSIPPI RIVER INTERBASIN STUDY –
BRANDON ROAD**

APPENDIX G - PHASE I HTRW SITE ASSESSMENTS

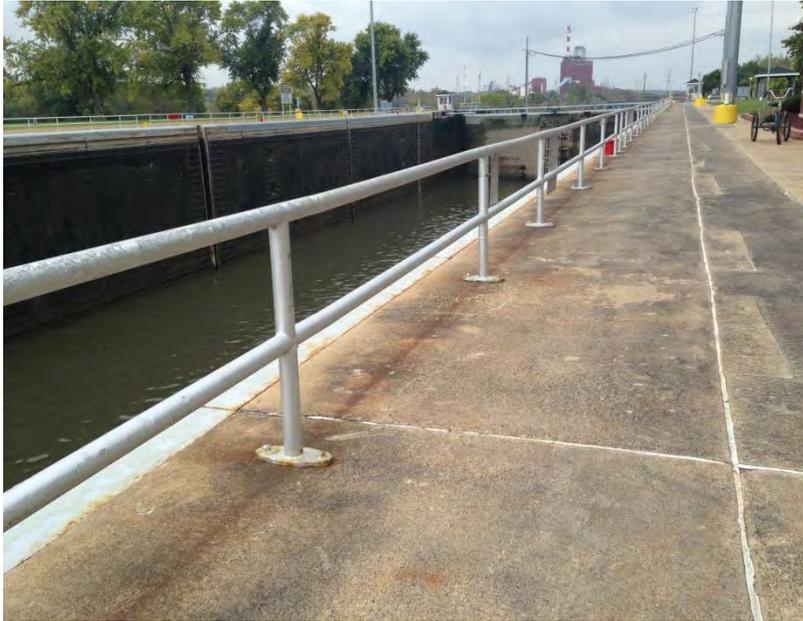
68. Handrail around lock chamber, tested positive for lead

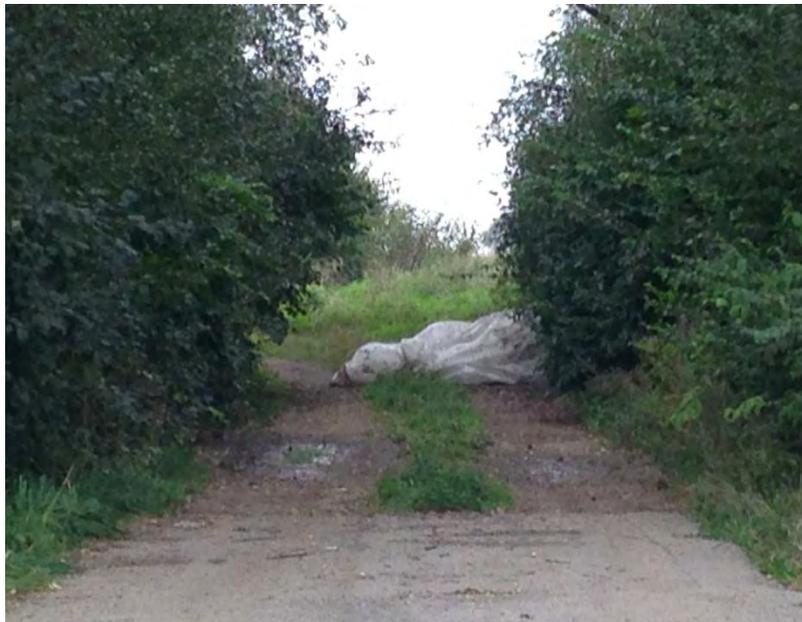
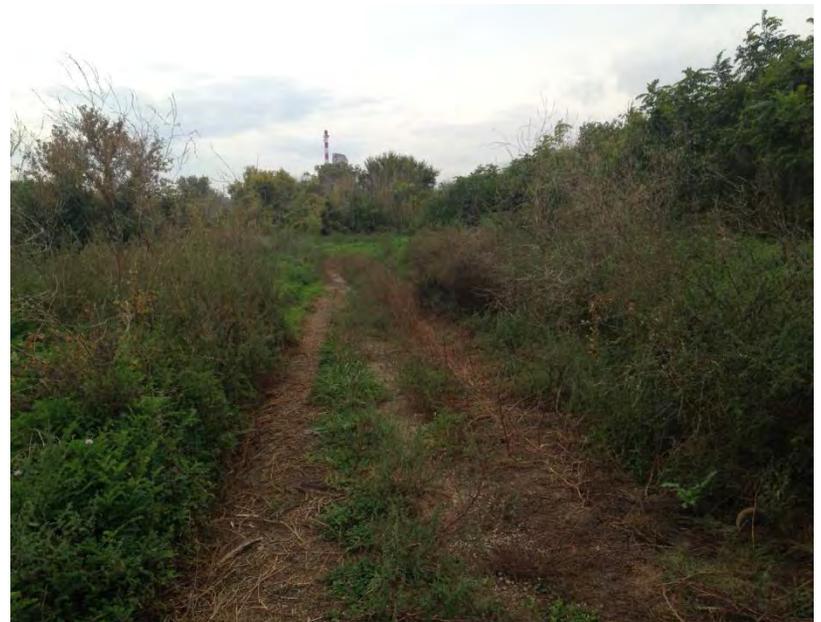
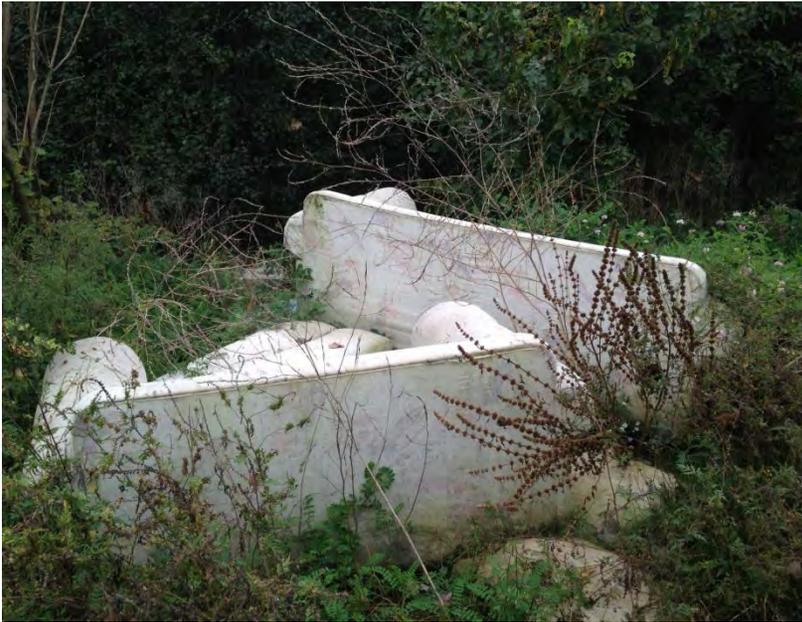
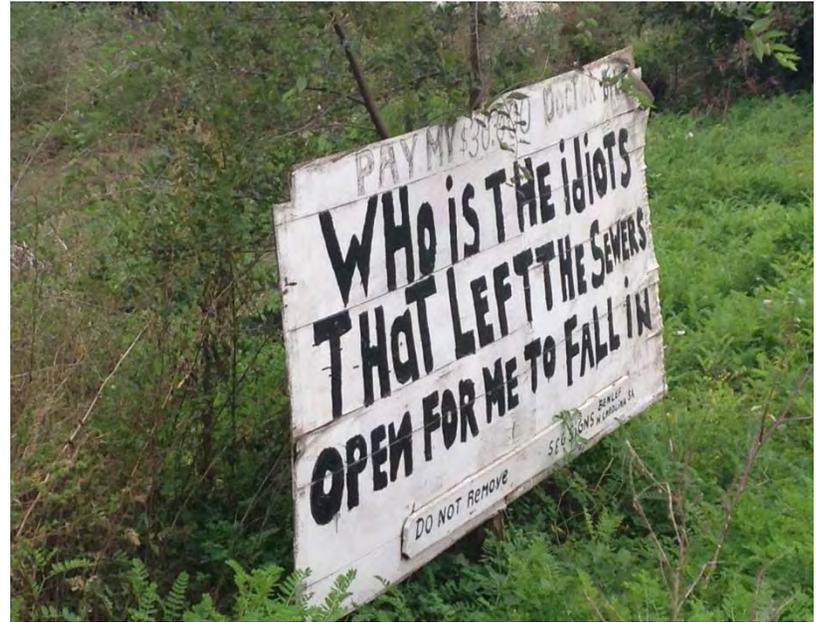
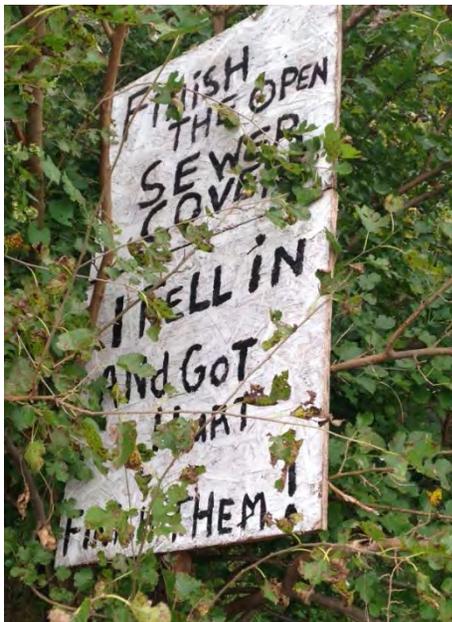
The large parcel located north of the approach channel, west of Brandon Road and South of Channahon Road was also littered with debris as shown in Photos 70 through 74, Attachment F. Aside from the minor illegal dumping activities that have clearly taken place, no visual evidence of a historical landfill was observed. However, observations of this area were limited by the density of vegetation present on site.

70. Dirt road proceeds west beyond asphalt turnaround, debris

71. Dirt road heading west from Brandon Road into State-owned vacant land, north of river

72. Abandoned couches, west of Brandon Road on north side of river

73. Signage found west of Brandon Road on north side of river

74. Signage found west of Brandon Road on north side of river

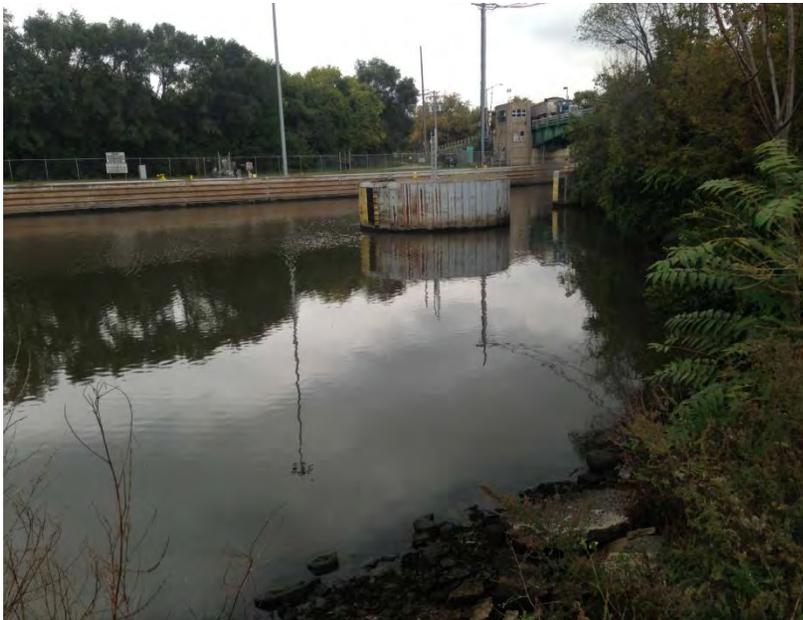
78. West of Brandon Road, south side of river, facing north.

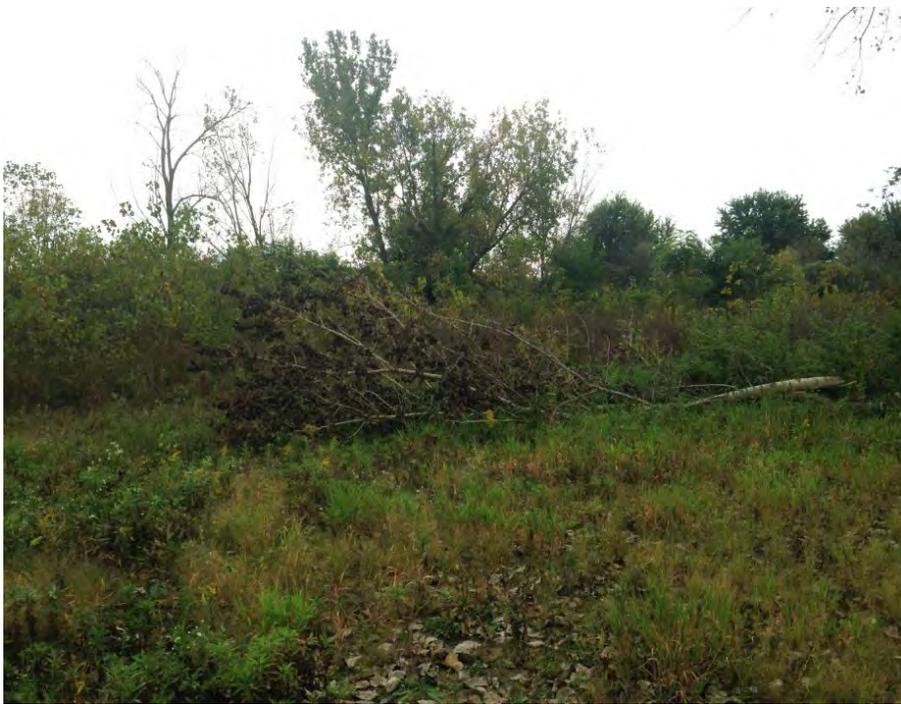
80. West side of Brandon Road, south of river, facing west

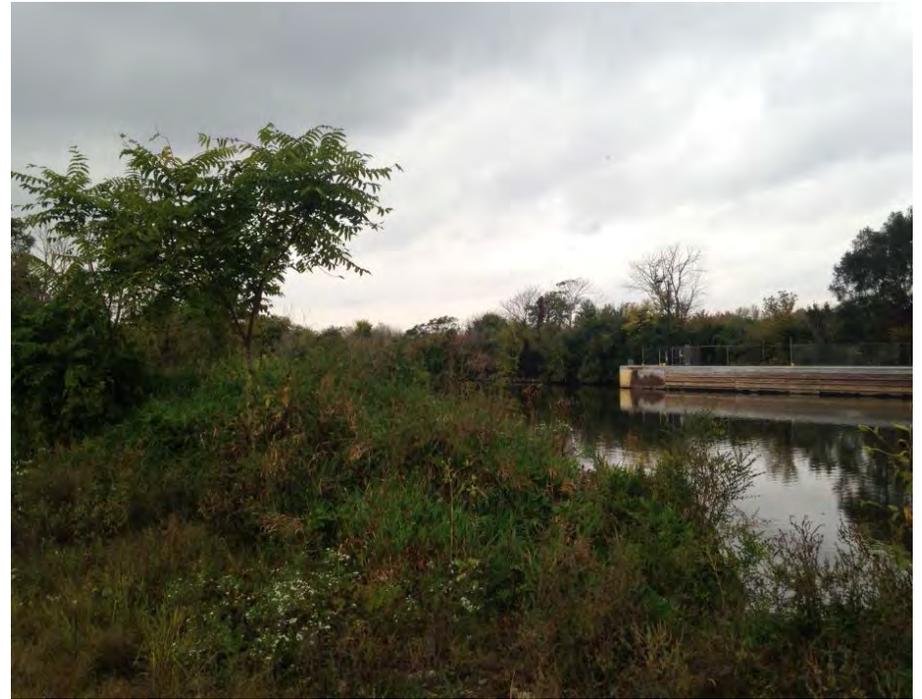
81. West side of Brandon Road, south of river, facing west

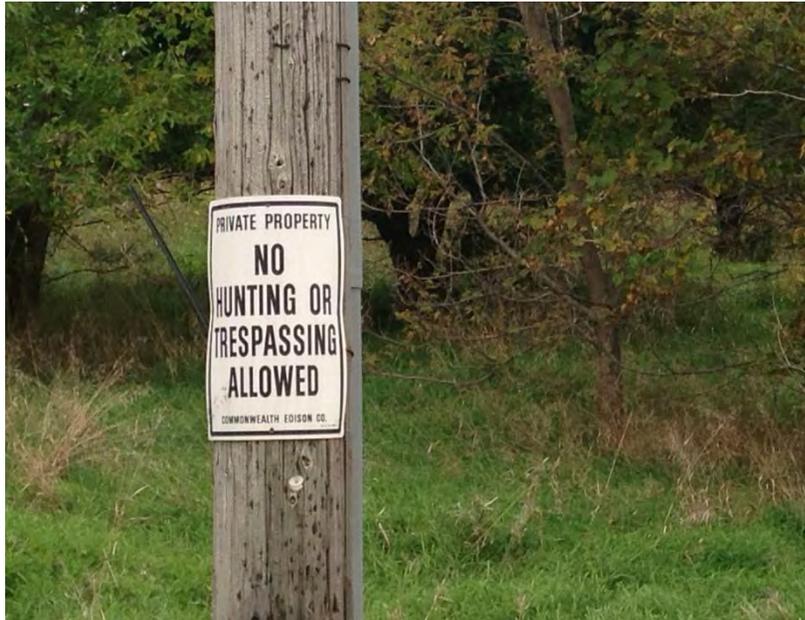
82. View east from Route 6, south of Brandon Road. Access restricted.

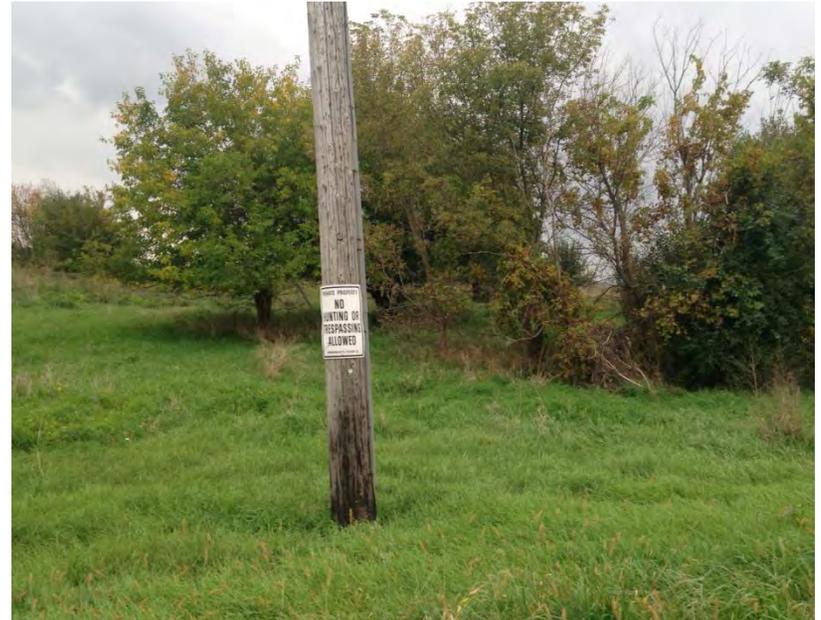
83. View east from Route 6, south of Brandon Road. Access restricted..

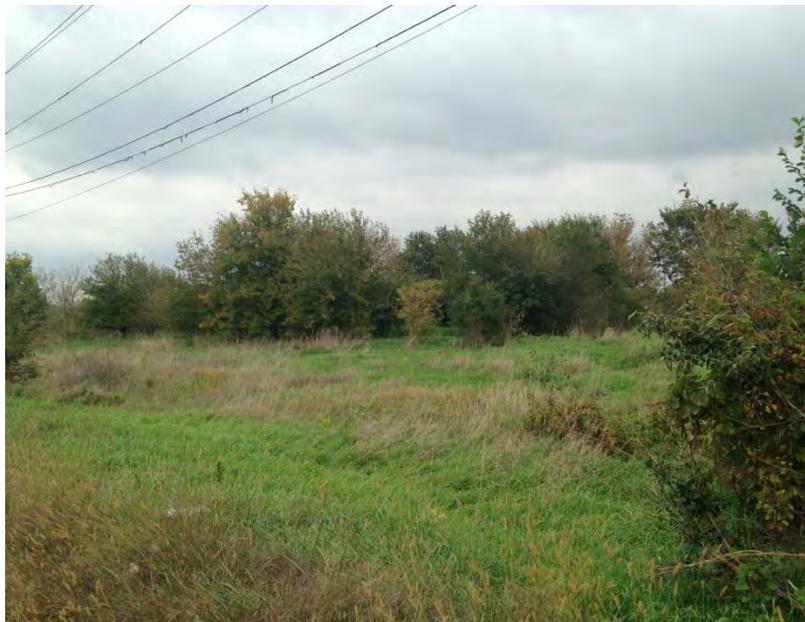
84. View east from Route 6, south of Brandon Road. Access restricted.

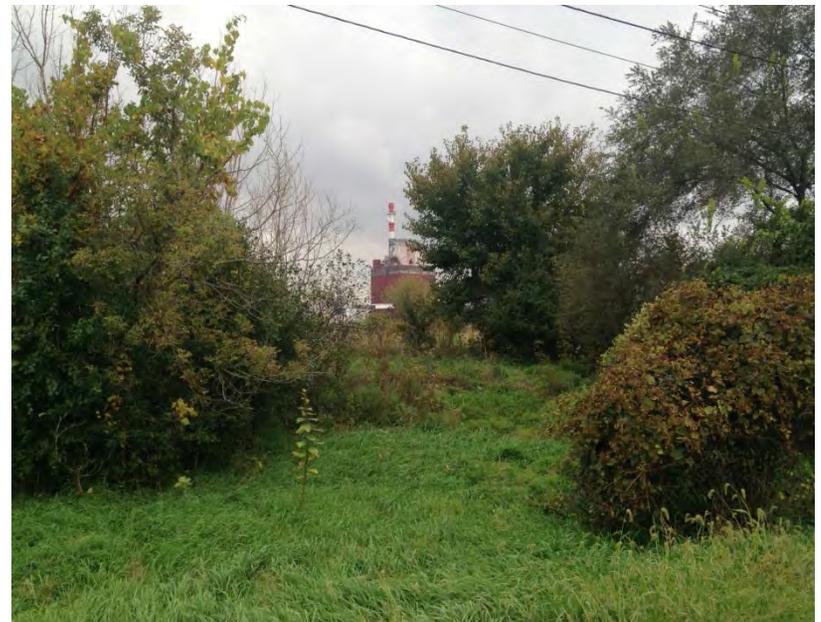
85. View east from Route 6. Generating station in background.

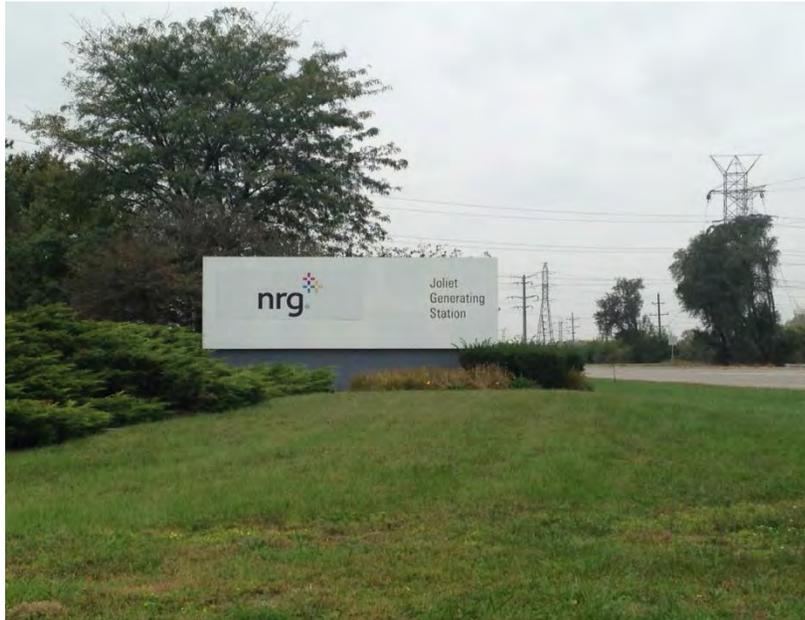
86. Neighbor to the west of large vacant property, Joliet Generating Station

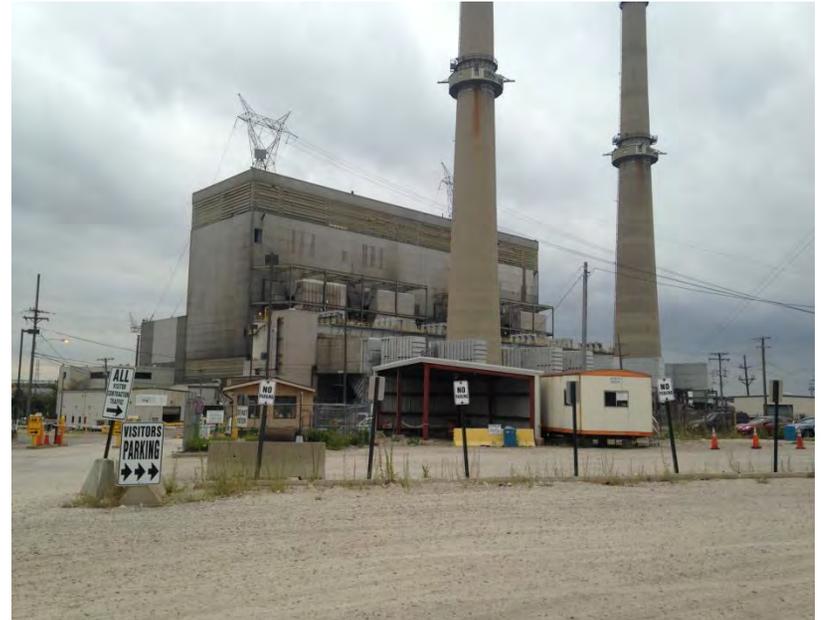
87. Neighbor to the west of large vacant property, Joliet Generating Station

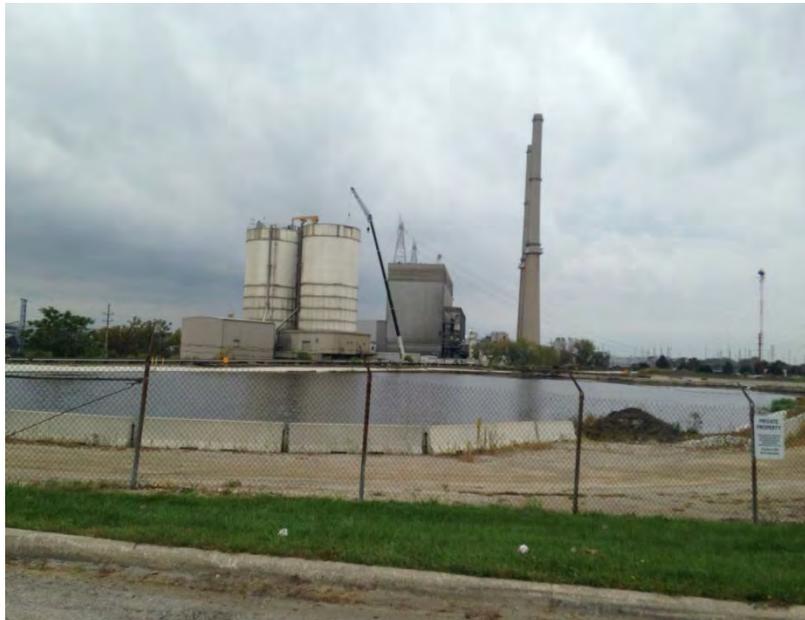
88. Neighbor to the west of large vacant property, Joliet Generating Station

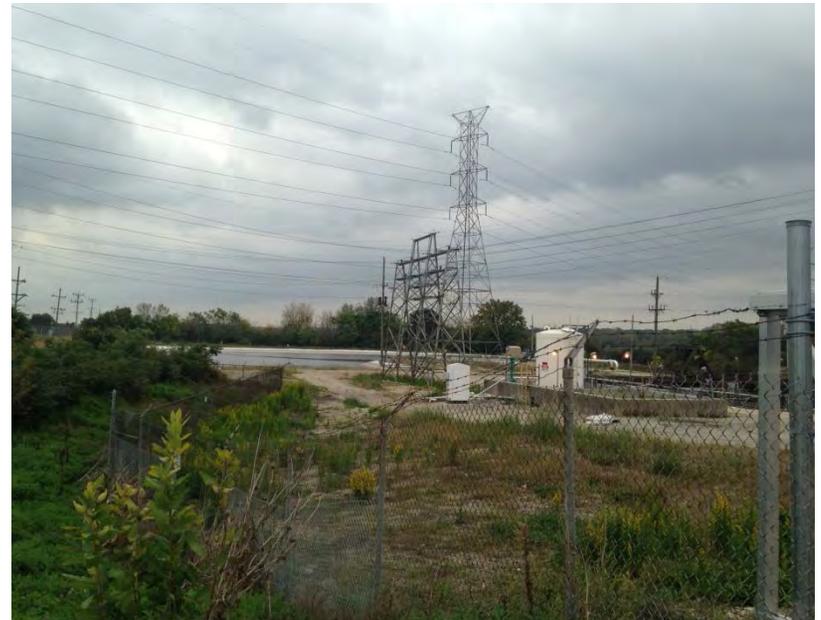
89. Fence line between large vacant property and Joliet Generating Station

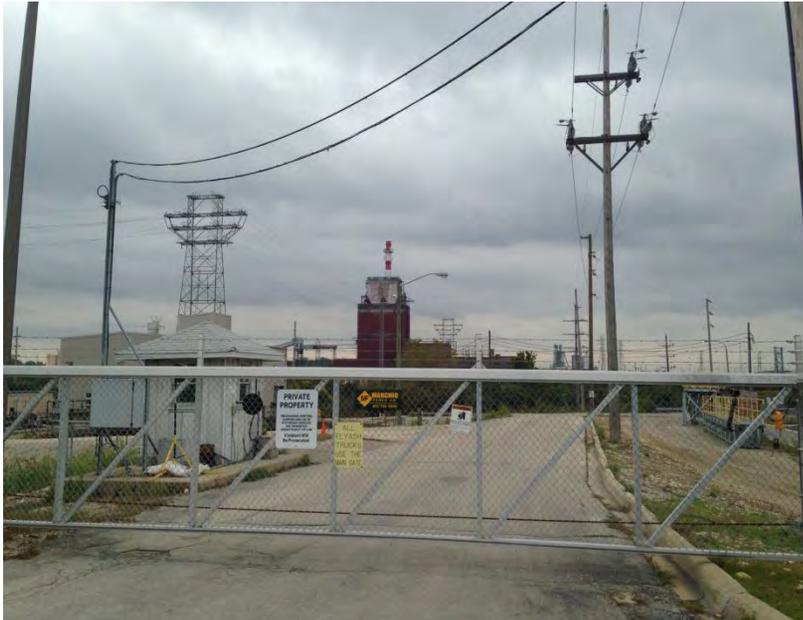
90. Neighbor to the west of large vacant property, Joliet Generating Station

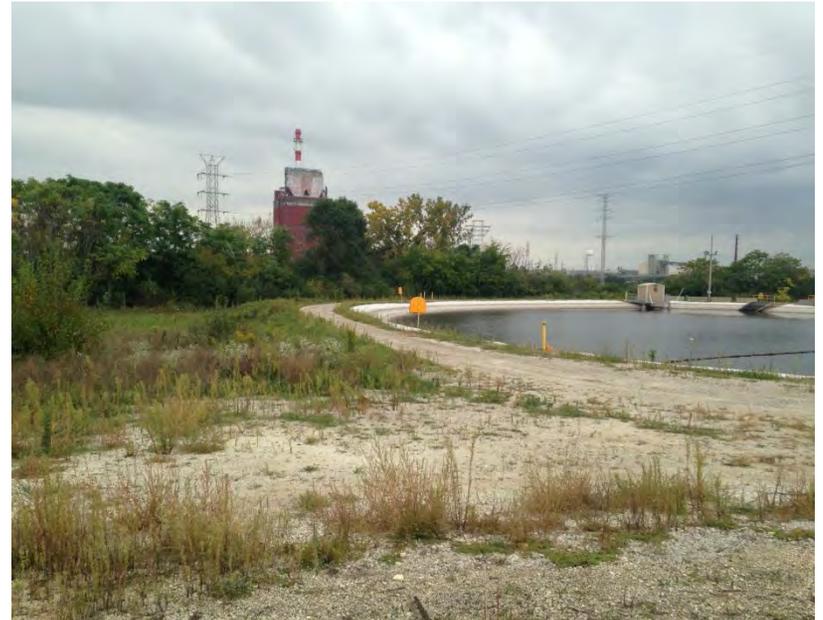
91. Neighbor to the west of large vacant property, Joliet Generating Station

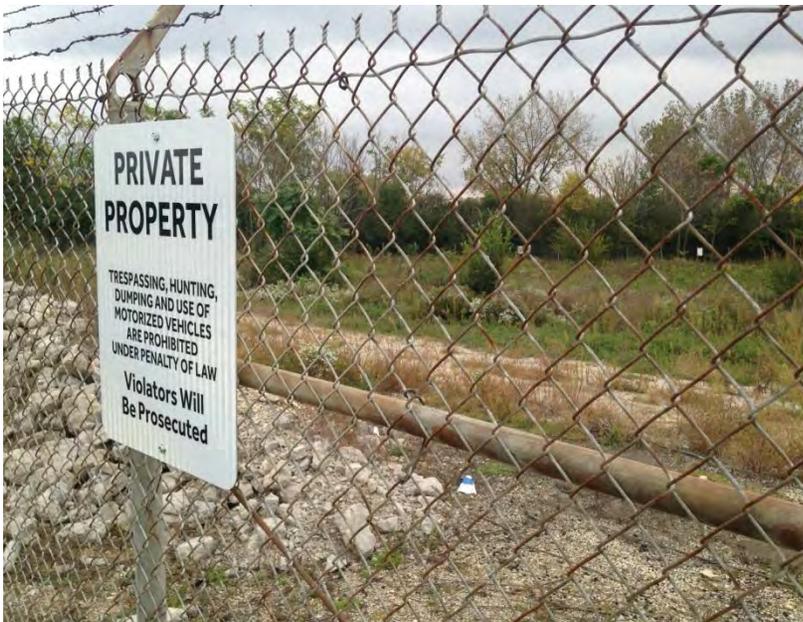
92. Neighbor to the west of large vacant property, Joliet Generating Station

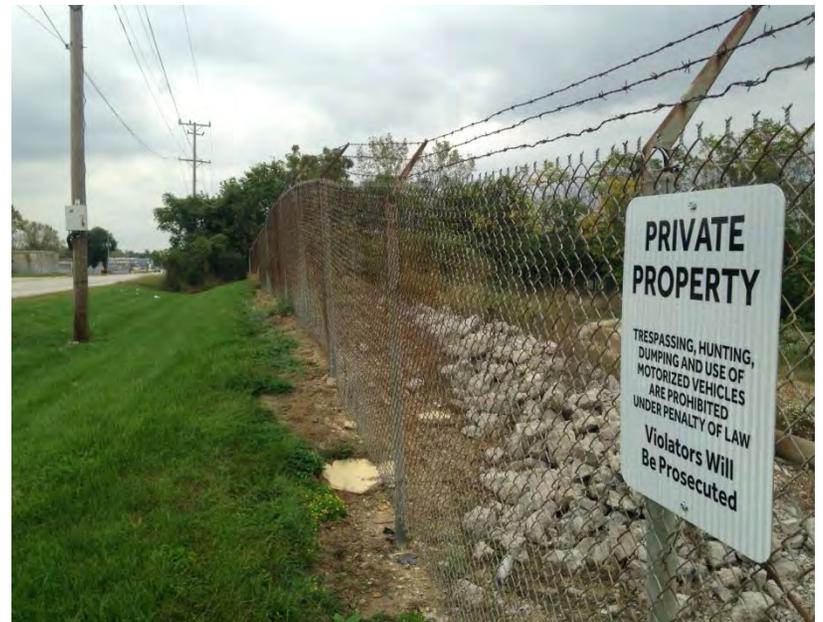
93. Neighbor to the west of large vacant property, Joliet Generating Station
